REFURBISHMENT AND DEMOLITION
ASBESTOS SURVEY REPORT

East Worlington Parish Hall
East Worlington
Credton
EX17 4TS

JOB NO: J017458

DATE OF SURVEY: 15 Sep 2015

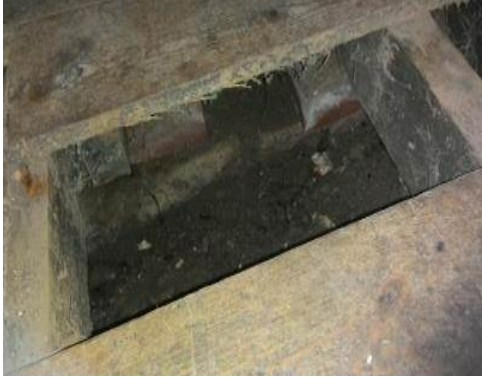
Item No.	Site Sample Reference	Location	Description of Material and Recommended Action	Area or Quantity	Photographs		
1	AJ002394	Ground Floor. Room 1 (Main Hall).	Cement packing to floor structure within floor void - throughout. Contains Chrysotile asbestos materials. Materials can be removed by a non-licensed contractor in accordance with the Control of Asbestos Regulations 2012. Recommended Action D	<10m ²

Material Risk Assessment							
Product Type	Condition	Surface Treatment	Asbestos Type	Risk Factor		Risk Level	Accessibility
1	0	(1) Surface Sealed	1	3	Very Low	Low	NNL

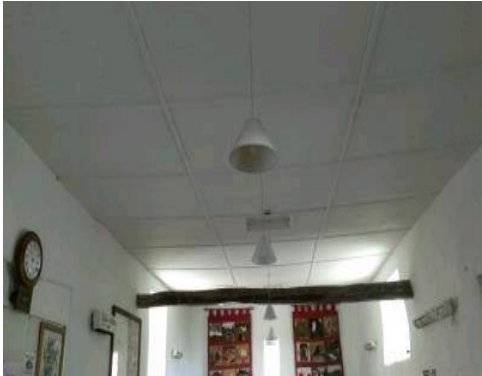
Item No.	Site Sample Reference	Location	Description of Material and Recommended Action	Area or Quantity	Photographs		
2	AJ002395	Ground Floor. Room 1 (Main Hall).	Cement ceiling lining. Contains Chrysotile asbestos materials. Materials can be removed by a non-licensed contractor in accordance with the Control of Asbestos Regulations 2012. Recommended Action D	150m ²

Material Risk Assessment							
Product Type	Condition	Surface Treatment	Asbestos Type	Risk Factor		Risk Level	Accessibility
1	0	(1) Surface Sealed	1	3	Very Low	Low	NNL

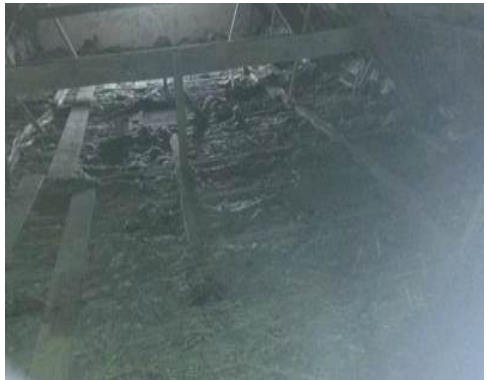
Item No.	Site Sample Reference	Location	Description of Material and Recommended Action	Area or Quantity	Photographs		
3	AJ002396	Roof Void. Room 1 (Main Hall).	Insulation and debris within roofspace. No Asbestos Detected. No further action required. Recommended Action -	150m ²

Material Risk Assessment							
Product Type	Condition	Surface Treatment	Asbestos Type	Risk Factor		Risk Level	Accessibility
-	-	-	-	-	-	-	-

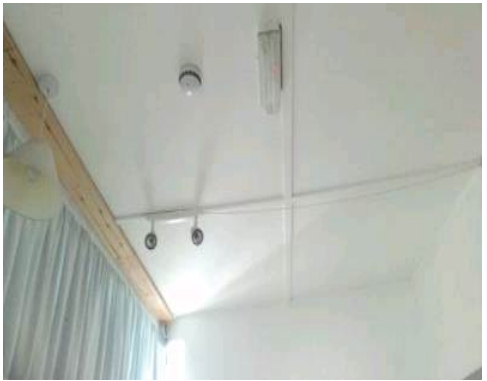
Item No.	Site Sample Reference	Location	Description of Material and Recommended Action	Area or Quantity	Photographs		
4	AS PER SAMPLE AJ002395	Ground Floor. Room 2 (Stage Area).	Cement ceiling lining (as sample AJ002395). Strongly presumed to contain Chrysotile asbestos materials. Materials can be removed by a non-licensed contractor in accordance with the Control of Asbestos Regulations 2012. Recommended Action D	10m ²

Material Risk Assessment							
Product Type	Condition	Surface Treatment	Asbestos Type	Risk Factor		Risk Level	Accessibility
1	0	(1) Surface Sealed	1	3	Very Low	Low	NNL

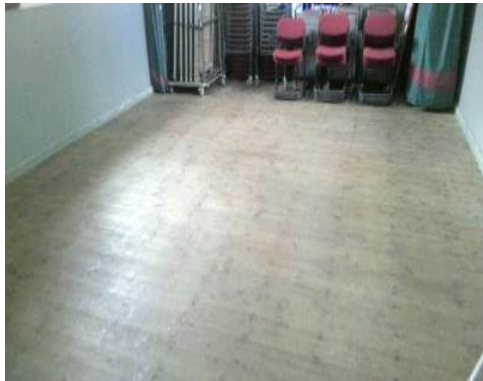
Item No.	Site Sample Reference	Location	Description of Material and Recommended Action	Area or Quantity	Photographs		
5	AJ002397	Ground Floor. Room 1 (Main Hall).	Dust/ debris sample within floor void. No Asbestos Detected. No further action required. Recommended Action -	150m ²

Material Risk Assessment							
Product Type	Condition	Surface Treatment	Asbestos Type	Risk Factor		Risk Level	Accessibility
-	-	-	-	-	-	-	-

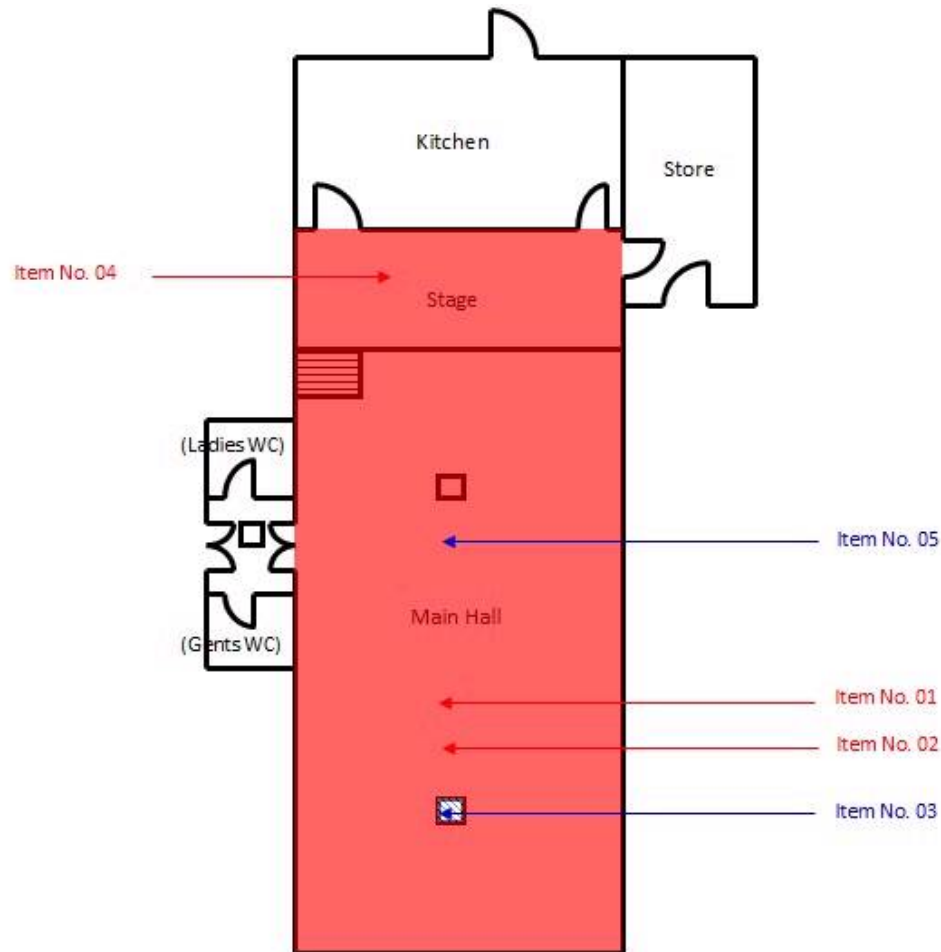
10.1 Ground Floor

Areas containing positive ACMS
