HSG 264
MANAGEMENT
ASBESTOS SURVEY REPORT

East Worlington Parish Hall
East Worlington Crediton
Devon
EX17 4TS

JOB NO: J005422
DATE OF SURVEY: 17 Sep 2013
DATE OF ISSUE: 18 Sep 2013
SCOPE OF WORKS: Management asbestos survey of the whole property

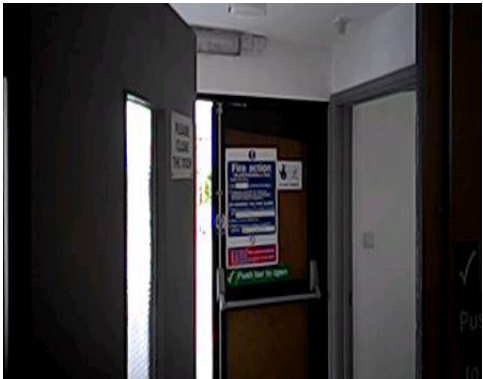
Item No.	Site Sample Reference	Location	Description of Material and Recommended Action		Area or Quantity	Photographs	
1	No Sample Taken	Ground Floor. Room 1 (Entrance Foyer).	Accessed - no suspect materials found. No further action required.		N/A

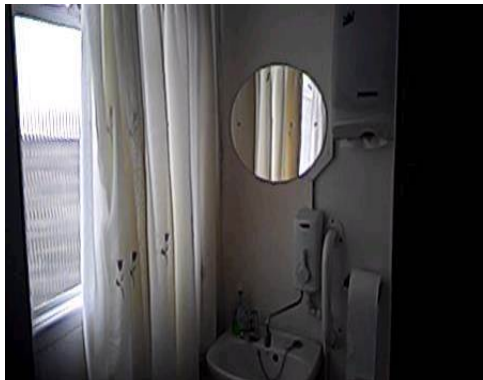
Item No.	Site Sample Reference	Location	Description of Material and Recommended Action		Area or Quantity	Photographs	
2	No Sample Taken	Ground Floor. Room 2 (Ladies WC).	Accessed - no suspect materials found. No further action required.		N/A

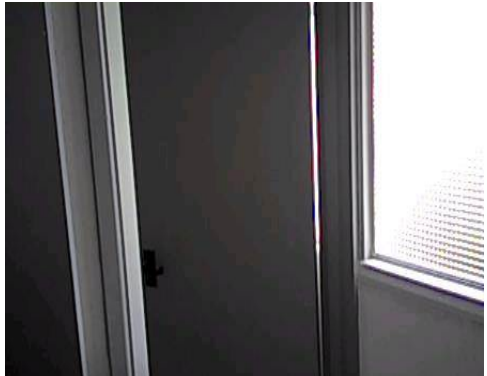
Item No.	Site Sample Reference	Location	Description of Material and Recommended Action	Area or Quantity	Photographs		
3	No Sample Taken	Ground Floor. Room 3 (Gents WC).	Accessed - no suspect materials found. No further action required. Recommended Action -	N/A

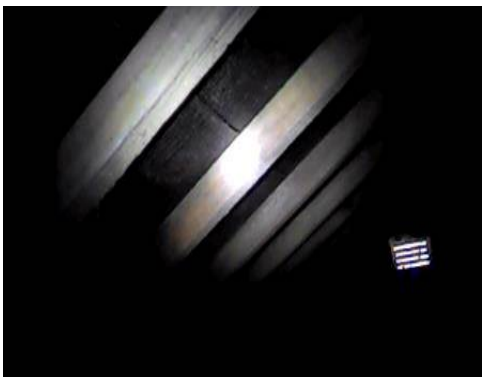
Item No.	Site Sample Reference	Location	Description of Material and Recommended Action	Area or Quantity	Photographs		
4	EG000540	Roof Void. Room 1 (Entrance Roofspace).	Bitumen roofing felt. No Asbestos Detected. No further action required. Recommended Action -	15m ²

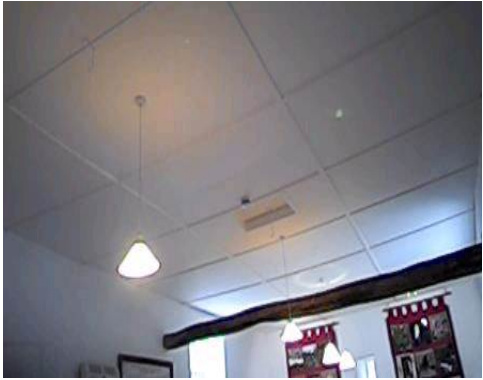
Item No.	Site Sample Reference	Location	Description of Material and Recommended Action	Area or Quantity	Photographs		
5	EG000541	Ground Floor. Room 4 (Main Hall).	Cement ceiling lining. Contains Chrysotile asbestos materials. Materials can be removed by a non-licensed contractor in accordance with the Control of Asbestos Regulations 2012. Recommended Action D	80m ²

Material Risk Assessment							
Product Type	Condition	Surface Treatment	Asbestos Type	Risk Factor		Risk Level	Accessibility
1	0	(1) Surface Sealed	1	3	Very Low	Low	NNL

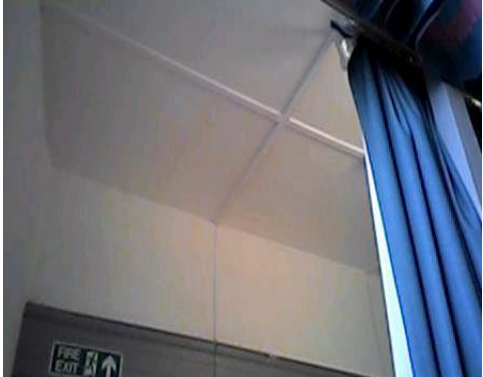
Item No.	Site Sample Reference	Location	Description of Material and Recommended Action	Area or Quantity	Photographs		
6	AS PER SAMPLE EG000541	Ground Floor. Room 5 (Stage Area).	Cement ceiling lining (as sample EG000541). Strongly presumed to contain Chrysotile asbestos materials. Materials can be removed by a non-licensed contractor in accordance with the Control of Asbestos Regulations 2012. Recommended Action D	20m ²

Material Risk Assessment							
Product Type	Condition	Surface Treatment	Asbestos Type	Risk Factor		Risk Level	Accessibility
1	0	(1) Surface Sealed	1	3	Very Low	Low	NNL

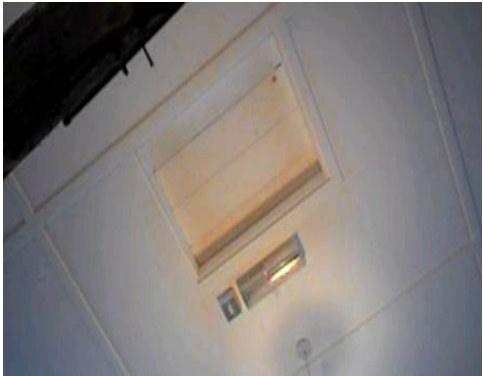
Item No.	Site Sample Reference	Location	Description of Material and Recommended Action	Area or Quantity	Photographs		
7	No Sample Taken	Roof Void. Room 2 (Main Hall Roofspace).	Accessed - no suspect materials found. No further action required. Recommended Action -	N/A

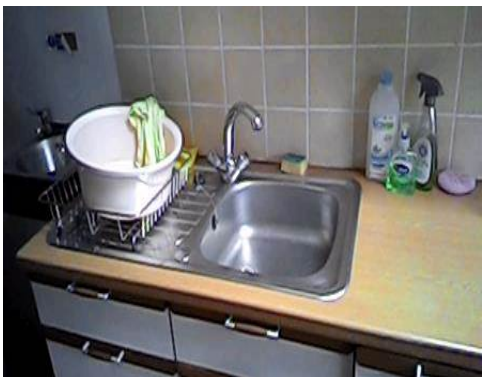
Item No.	Site Sample Reference	Location	Description of Material and Recommended Action	Area or Quantity	Photographs		
8	EG000542	Ground Floor. Room 6 (Kitchen).	Sound pad to sink unit. No Asbestos Detected. No further action required. Recommended Action -	1no.

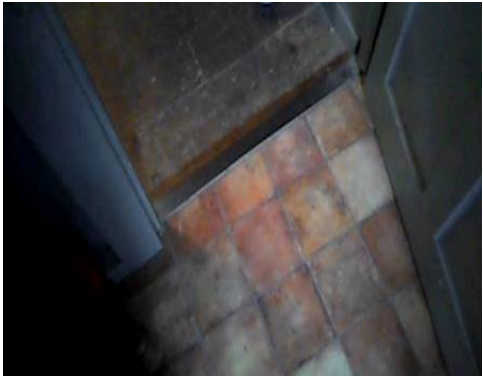
Item No.	Site Sample Reference	Location	Description of Material and Recommended Action	Area or Quantity	Photographs		
9	EG000543	Ground Floor. Room 6 (Kitchen).	Black bull nosing to steps. No Asbestos Detected. No further action required. Recommended Action -	2no.

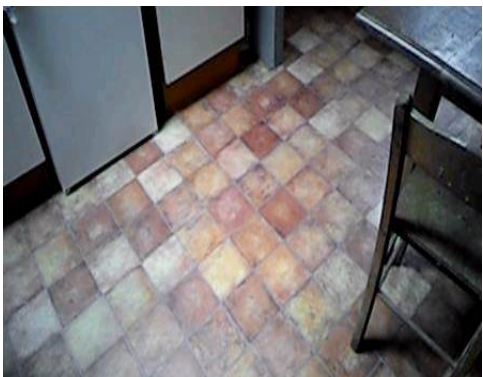
Item No.	Site Sample Reference	Location	Description of Material and Recommended Action	Area or Quantity	Photographs		
10	EG000544	Ground Floor. Room 6 (Kitchen).	Patterned lino flooring. No Asbestos Detected. No further action required. Recommended Action -	18m ²

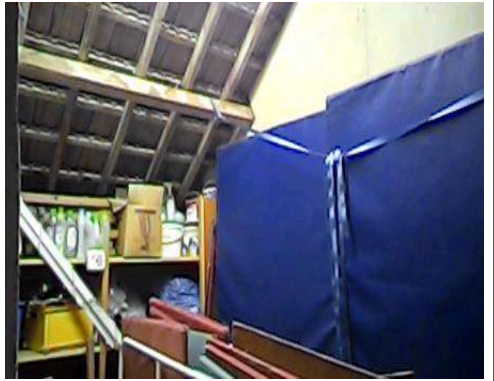
Item No.	Site Sample Reference	Location	Description of Material and Recommended Action	Area or Quantity	Photographs		
11	No Sample Taken	Ground Floor. Room 7 (Store).	Accessed - no suspect materials found. No further action required. Recommended Action -	N/A

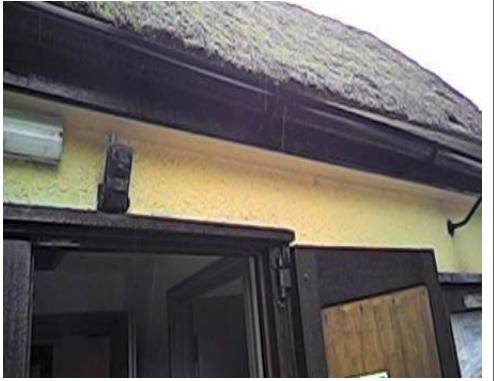
Item No.	Site Sample Reference	Location	Description of Material and Recommended Action	Area or Quantity	Photographs		
12	EG000545	External. Room 1 (Main Building).	Insulating board soffit boards to entrance area. Contains Chrysotile + Amosite asbestos materials. These materials can be removed by a licensed contractor only, in accordance with the Control of Asbestos Regulations 2012. Recommended Action D	5lm

Material Risk Assessment							
Product Type	Condition	Surface Treatment	Asbestos Type	Risk Factor		Risk Level	Accessibility
2	0	(1) Surface Sealed	2	5	Low	Low	L
