EAST WORLINGTON HOUSE EAST WORLINGTON DEVON

Results of a Desk-Based Assessment
Historic Building Recording & Archaeological Evaluation

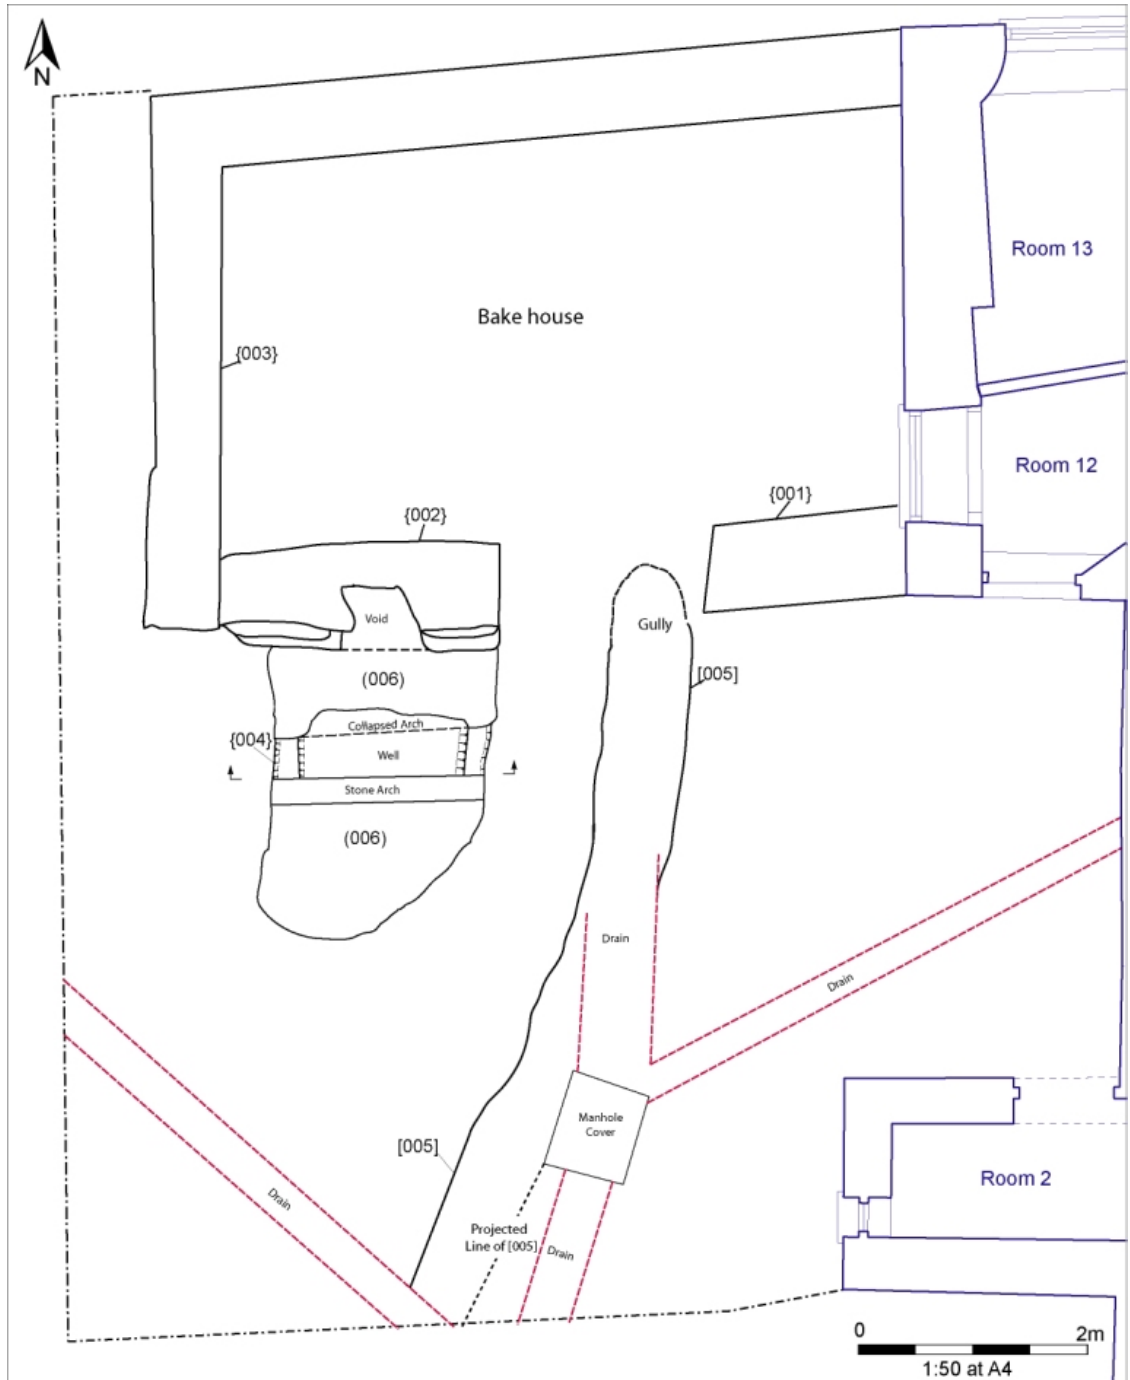
Figure 17: Trench 1, the area of the Bake House.

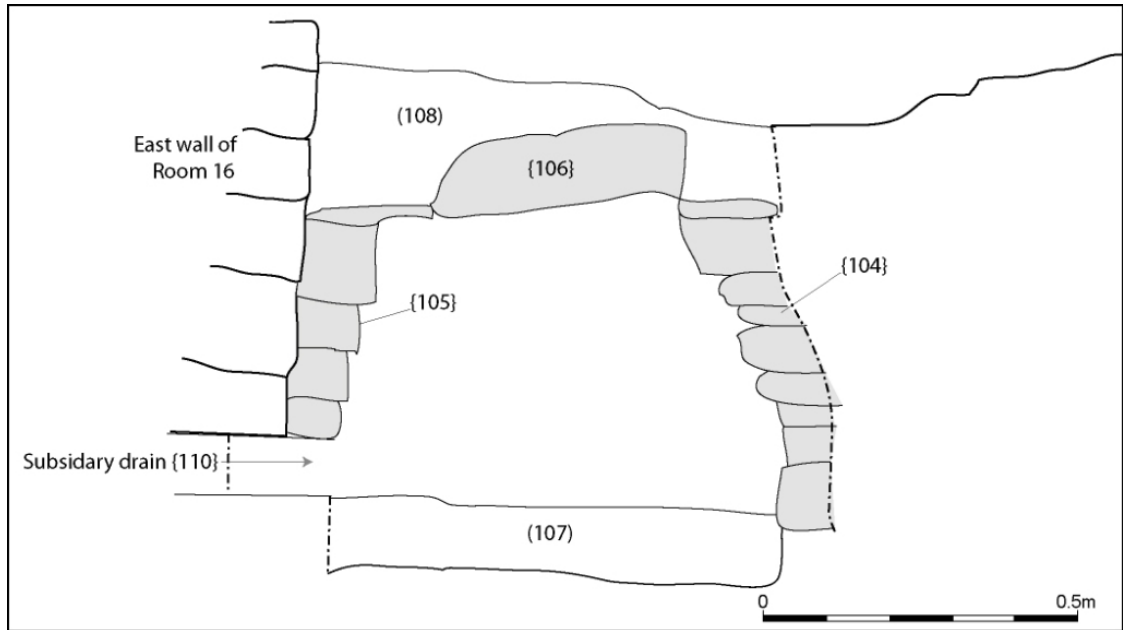
Figure 19: South-east facing section of the culvert.

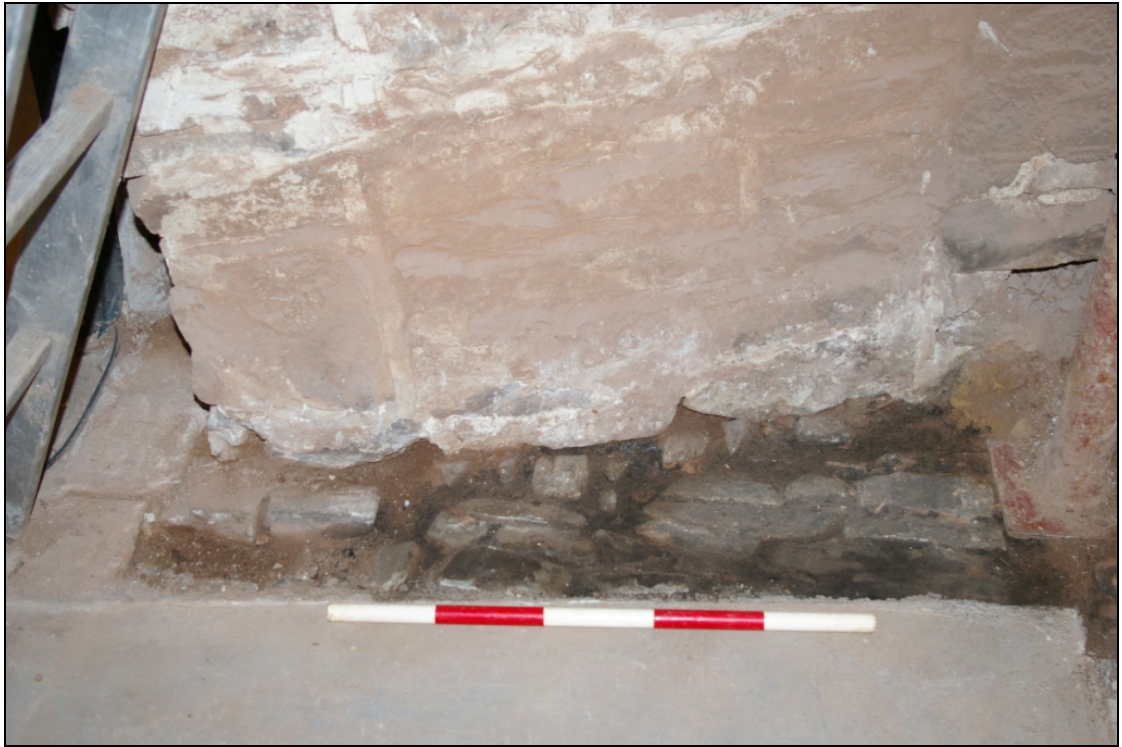
Figure 20: Cobbles (204) extending below {203}, viewed from the east (0.5m scale).
