Devon County Council Historic Environment Record

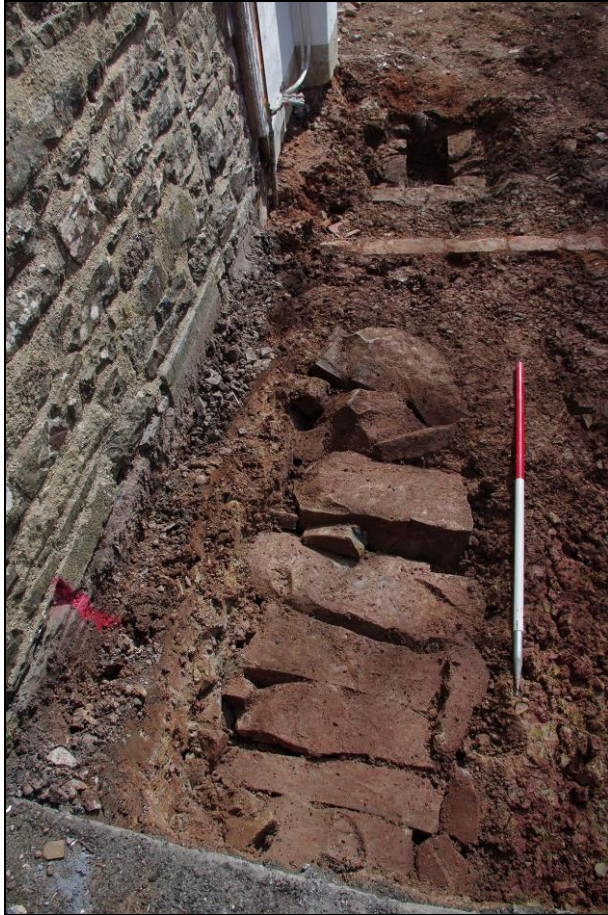
LEFT FIGURE 2: STONE DRAIN {106} RUNNING ALONG THE WEST SIDE OF THE VILLAGE HALL; VIEWED FROM THE NORTH (SCALE 1M).
RIGHT: FIGURE 3: AS ABOVE, WITH THE CAPPING STONES REMOVED AND SHOWING THE BLACK ALKATHENE WATER PIPE.

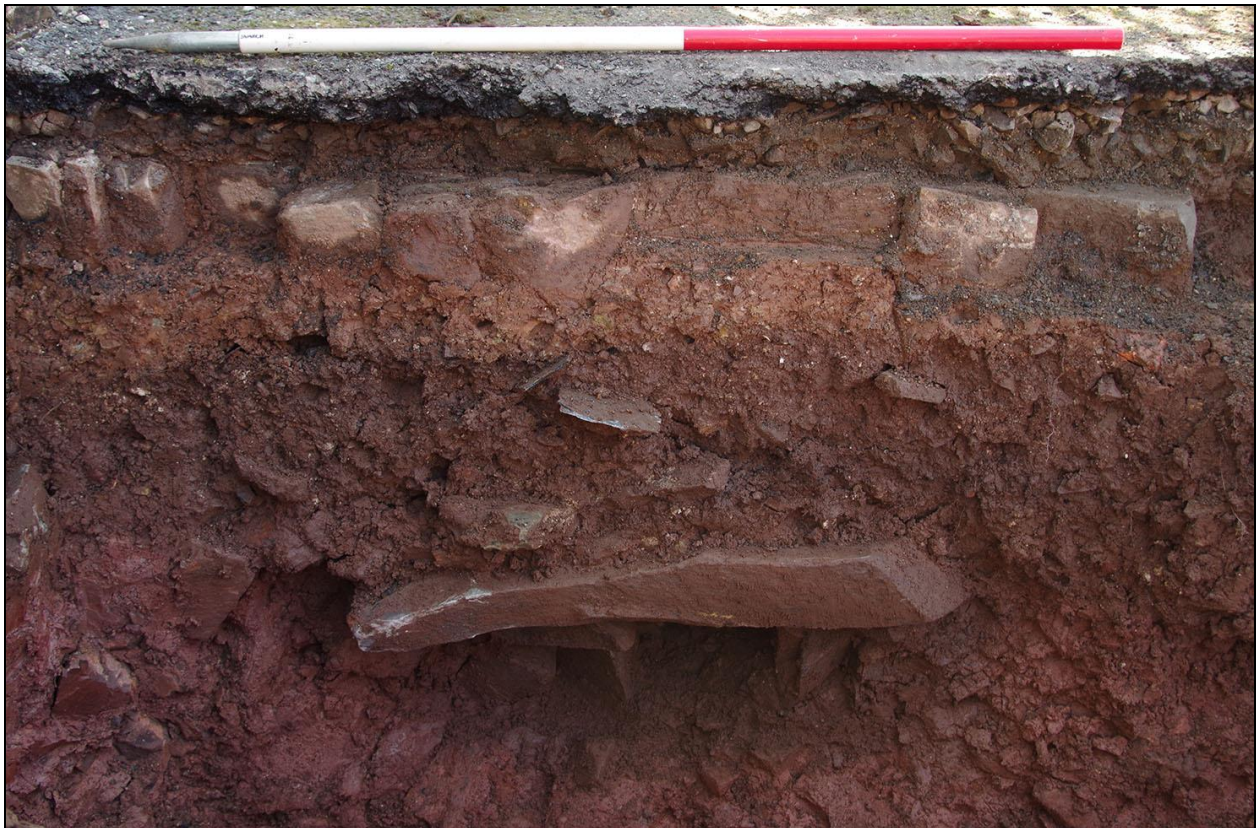
FIGURE 4: NORTH-FACING SECTION OF STONE DRAIN {106} (SCALE 1M).
