THE PARISH HALL EAST WORLINGTON DEVON

Results of a Desk-Based Assessment
&
Historic Building Survey

Report No.: 130215
Date: 15/02/2013
Authors: T. Green
D.Laing-Trengove

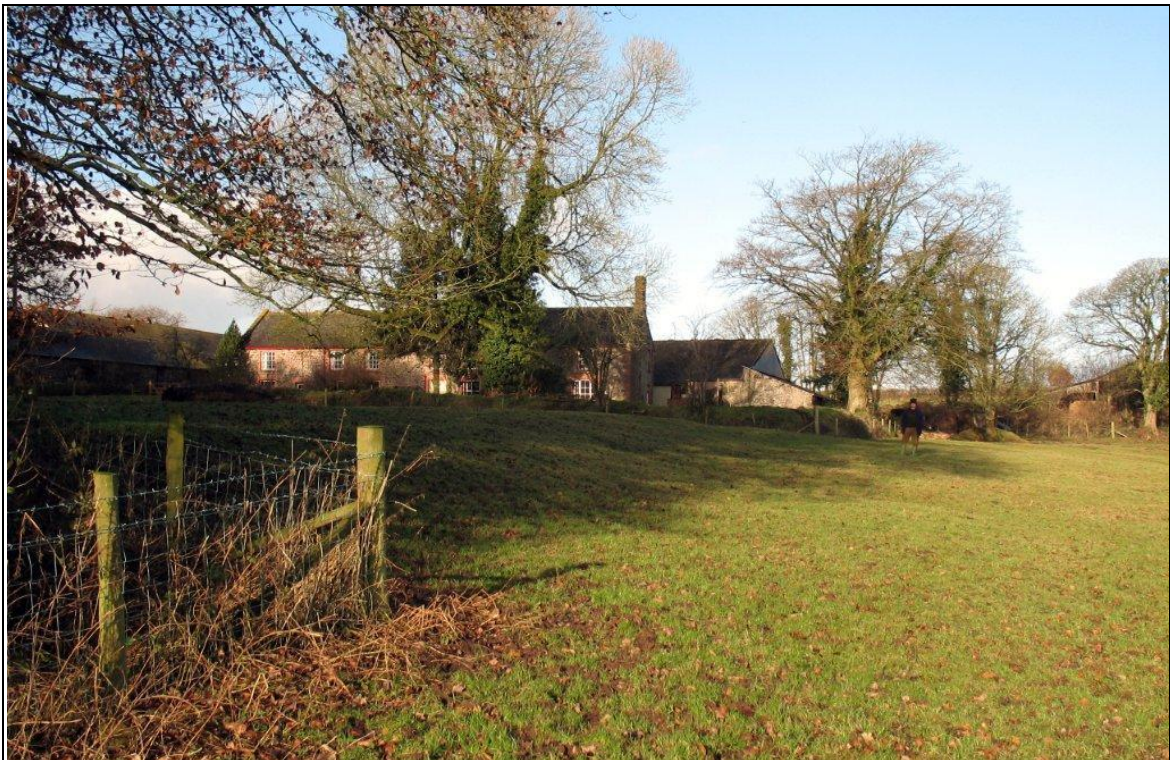
Figure 3: Photograph of the low bank, part of the ‘manorial enclosure’ boundary?

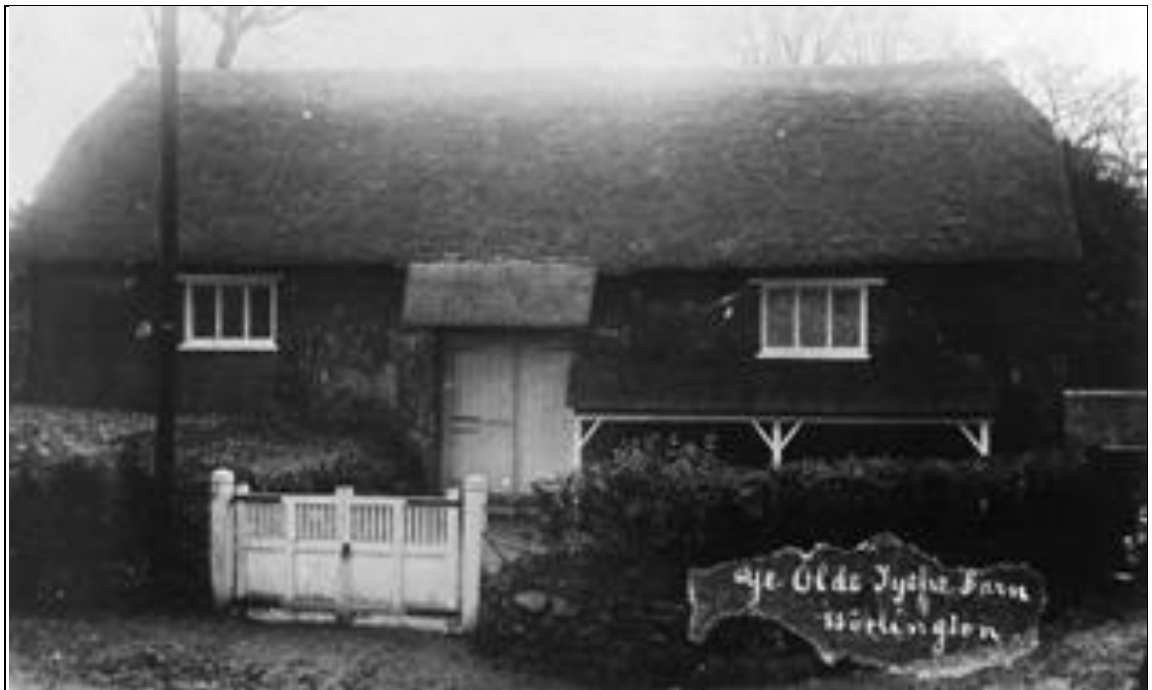
Figure 4: Photograph of the building dating from the early part of the 20th century, showing the mullioned windows, ‘pent house’ and verandah.

This description fits nicely with an undated photograph of the building from the early part of the 20th century (Figure 4).

The oak mullioned windows referred to above are presumably those mentioned in the listing of 1975 (Appendix 1):

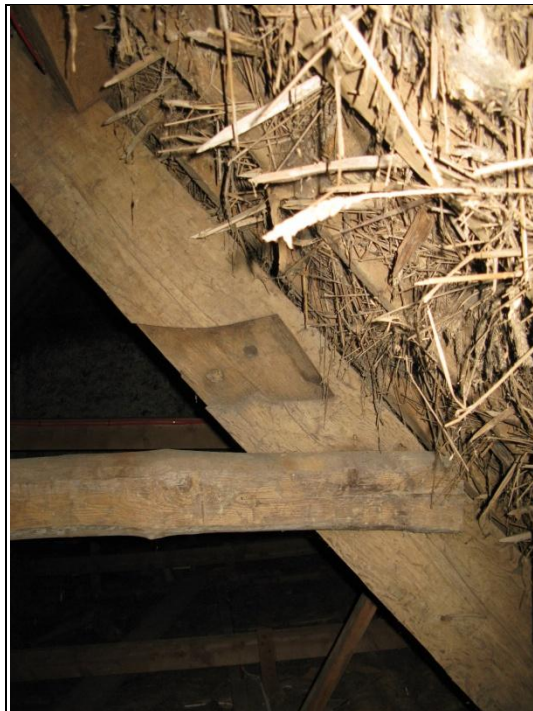
The remaining original oak timbers are confined to the northern end of the building and are comprised of the two blades of a roughly south of centre truss (Figure 9, T3), the western blade of the truss to the north of this (T2) and the eastern blade of the next most northerly truss (T1). All original purlins on both the east and west pitch of this north end remain, trenched into the backs of the earlier truss blades, and scarfed together at this point. The truss blades are set into the wall tops to east and west. All common rafters, battens and the ridge pole are modern and have been replaced during the 20th century, appearing contemporary with most of the replaced roof trusses to the south. The structure is now covered with a seemingly thin layer of thatch, with the feet of the spars protruding through for up to 0.15m (see Figure 8). All collars and tie beams on the remaining early truss blades are replacements, bolted or spiked to the faces of the blades. The single remaining complete A-Frame truss is lapped and pegged at the apex and the former collar was affixed via face pegged notched lap-joints (Figure 8).

Figure 8: The former collar joint above a later spiked timber on an early roof truss.
