## **SUPPORTING INFORMATION – HERITAGE STATEMENT**

**APPLICATION FOR:** Improvement Works to Kitchen & Roof & Isolated Wall Repair at East Worlington Parish Hall, East Worlington, Crediton Devon.

**APPLICATION TYPE:** Listed Building Consent

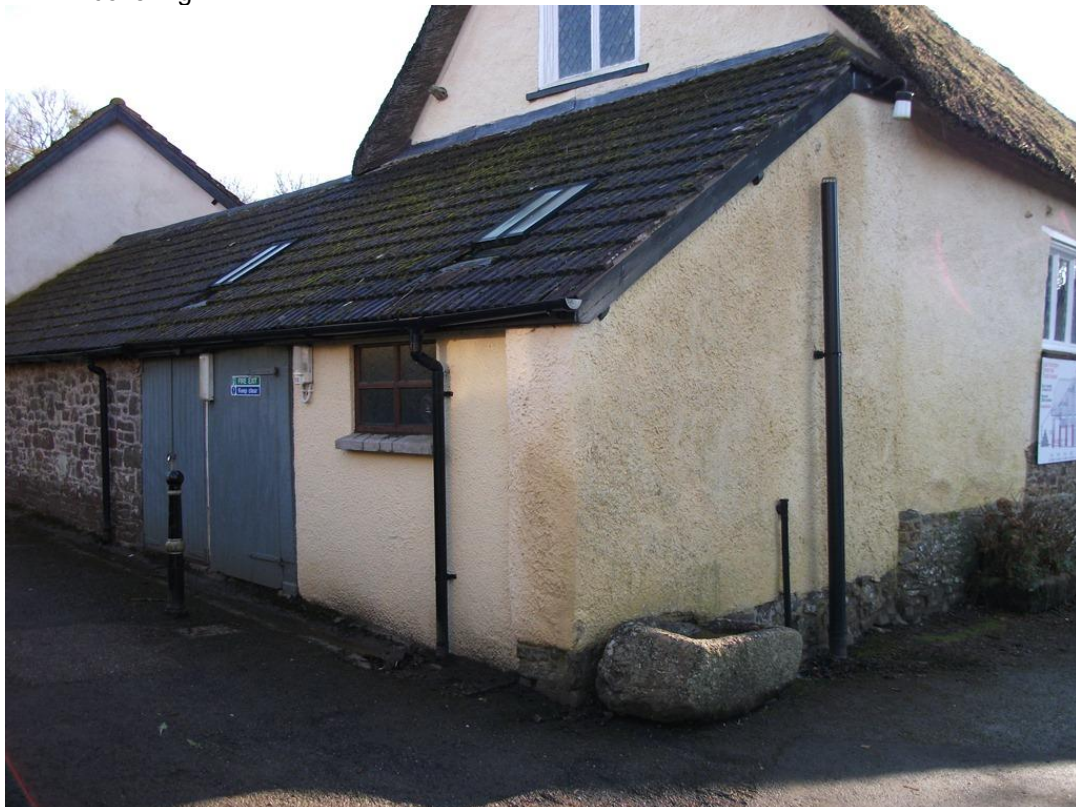
**2. Side Elevation – (North) – Showing concrete roof covering to be replaced with slate roof covering**

- 5.3.1 The existing concrete roof covering to the north elevation is believed to date from repairs to the buildings following the storms of 1987 when a number of the roof coverings forming the courtyard to East Worlington House sustained damage. It is most likely the original roof covering was a slate to match the adjacent school building and church.

- 5.3.2 It is proposed the existing concrete roof covering is removed and replaced with a second hand slate roof covering. The opportunity will also be taken to provide insulation at rafter level to current building regulation standards, complete with new internal plasterboard linings.

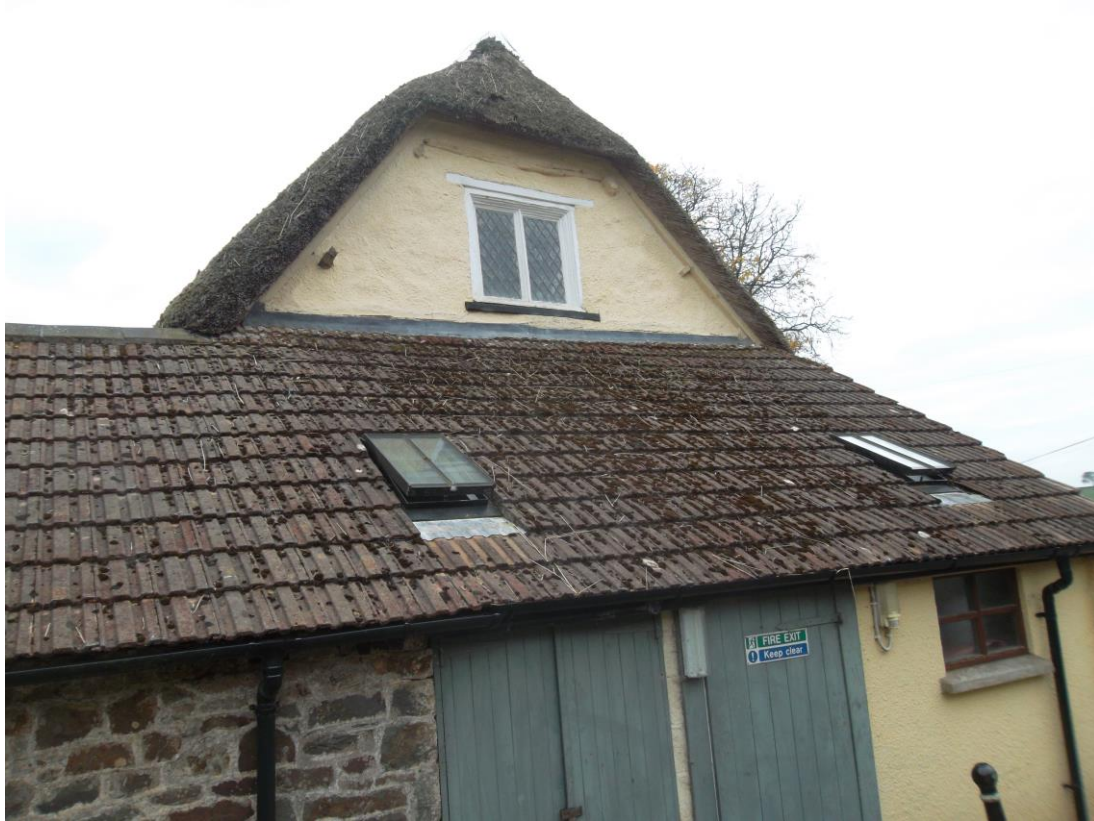
**3. Side Elevation – (North) – Showing concrete roof covering to be replaced with slate roof covering**

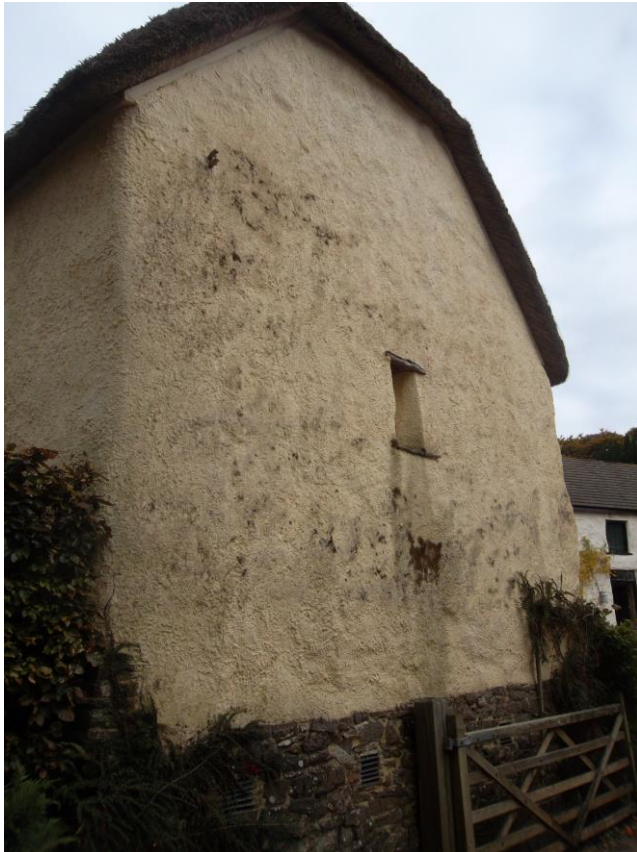
- 5.3.1 Vertical cracks have developed at the junction of the southern gable wall with the front and rear walls. The cracks have been monitored over a period of time and the results indicate some minor movement of the upper section of the walls. See Photograph nos. 5 and 6.
- 5.3.2 To prevent any further movement stitching repairs are proposed using 'Helibar' bars at 450mm vertical centres as detailed in the Structural Engineers details 14201/SK2. The works will be undertaken from outside and any minor damage to the external render will be made good with lime render and limewash to match existing.

**5. South Elevation – Location of stitching Repairs**

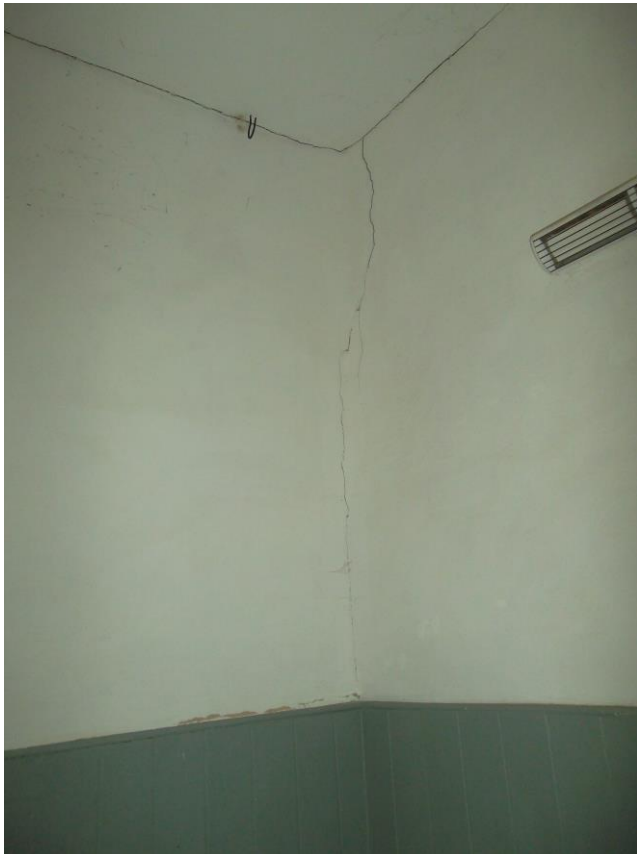
**6. Hall – Internal view of junction of south gable wall with front elevation, showing vertical crack.**

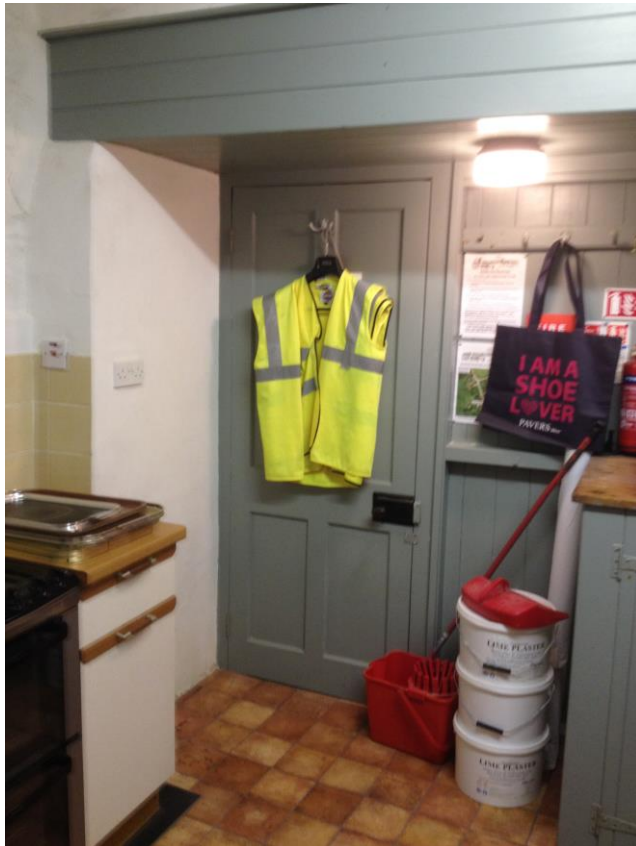
7. Kitchen – Door through to stage to be blocked up. Floor to be removed and new insulated floor to be provided, with slate or tile finish.

- 5.2.1 The existing kitchen will be stripped out back to existing finishes. The existing shallow concrete floor is currently provided directly over the earth sub-floor and without any form of damp proof membrane. This will be removed and the area excavated for the new insulated floor construction as detailed on the drawing. Within the new screed an under-floor heating circuit will be installed as an extension to the new system currently being installed. The floor will be finished with slate or complimentary tile.

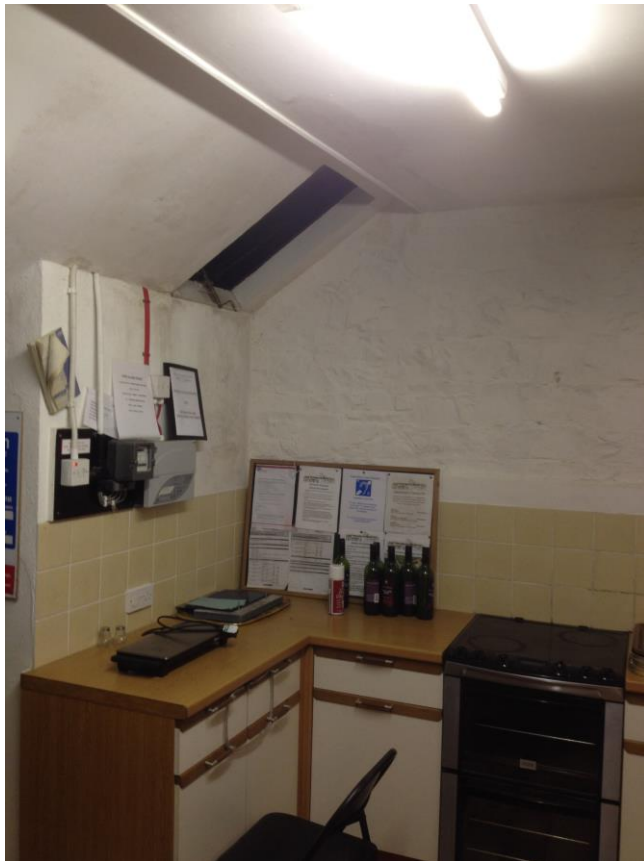
**9.** Kitchen – Painted stone walls to be plastered and decorated for hygiene purposes

- 5.2.2 The single skin blockwork wall fronting the access path to the school / church and the blockwork enclosing the oil tank will be lined internally with an insulation backed plasterboard lining thus reducing heat loss. The internal timber framework separating the kitchen from the stage will be lined internally with plasterboard to provide improved hygiene standards. There are no proposals to insulate the stone walls as this will affect breathability of the structure, however isolated areas of painted stonework will receive a lime plaster finish to match elsewhere in the kitchen.

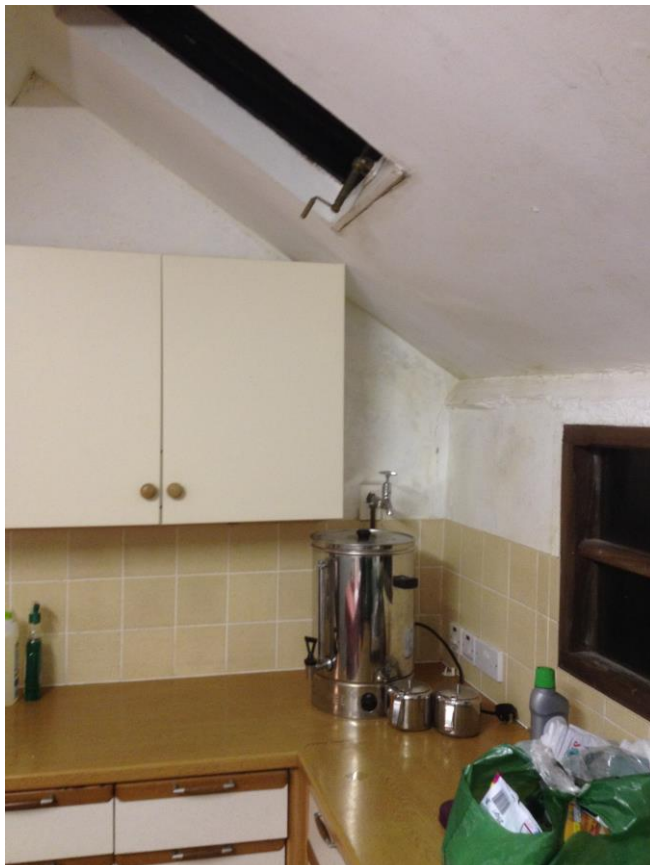
**10.** Kitchen – Single glazed timber window and rooflights to be replaced, single skin blockwork wall and sloping ceiling insulated.

- 5.2.3 The existing single glazed window to be removed and replaced with a painted hardwood timber window with sealed double glazed units complying with current building regulation standards.
- 5.2.4 New base and wall kitchen units will be provided in 'country house' kitchen style, along with new wall tiling, associated electrical works and decoration of walls with limewash.
- 5.2.5 A ventilation hood will be provided over the cooker position with extraction to outside via a roof ventilator tile.

- 5.3.4 New double glazed rooflights will replace the existing single glazed units. The existing roof light over the new oil tank location will be repositioned to provide light to the cooking area. The rooflights will be the black Velux 'Conservation' type with central glazing bar.
