Conservation and Celebration: A Century of Serving Our Community as a Parish Hall

Skills and Techniques of the Archaeologist

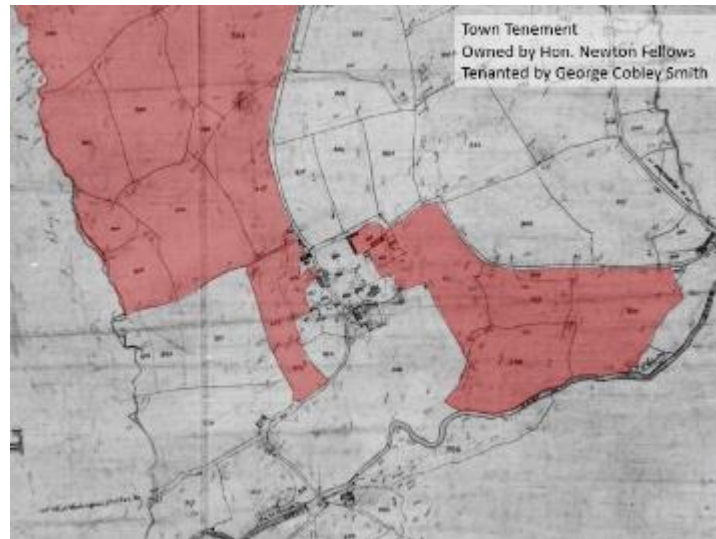
This Map Highlights Some of the Land Associated with Town Tenement

The information about Town Tenement are provided in the details below:

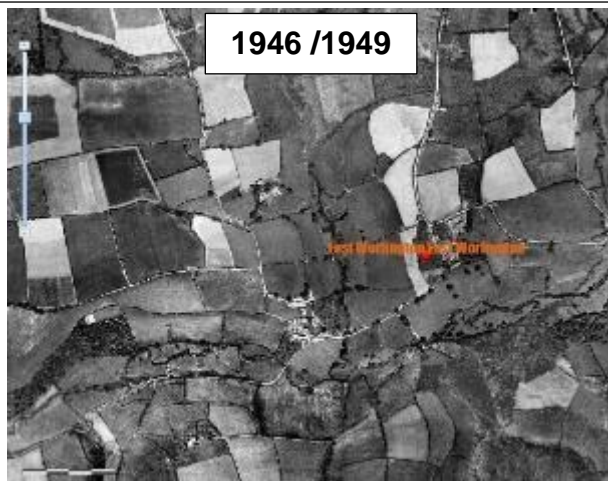
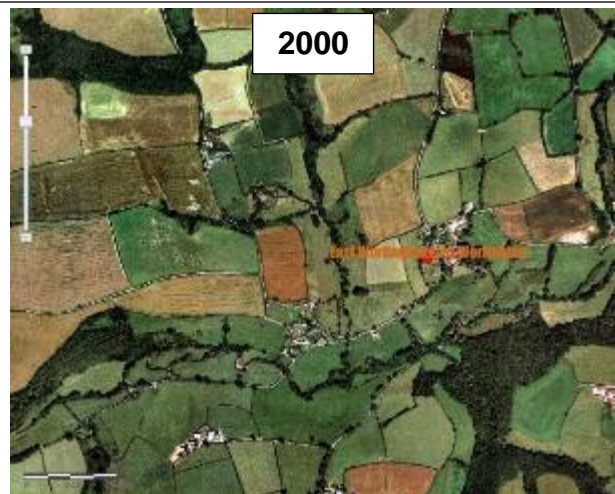
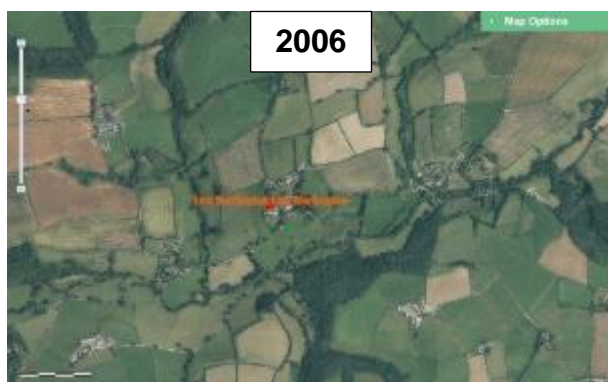
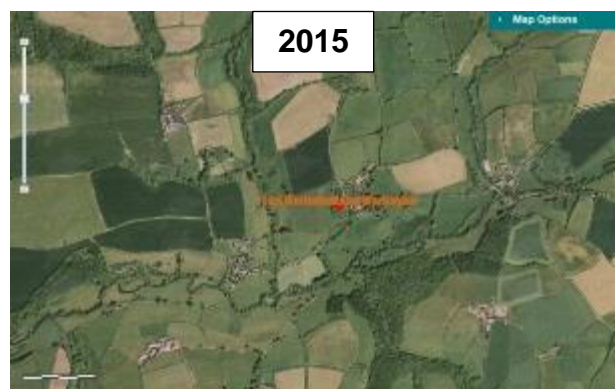
These are Aerial Photographs of East Worlington in Different Years Showing Field Shapes

Field shapes and their arrangements provide one source of evidence about their origins and uses.

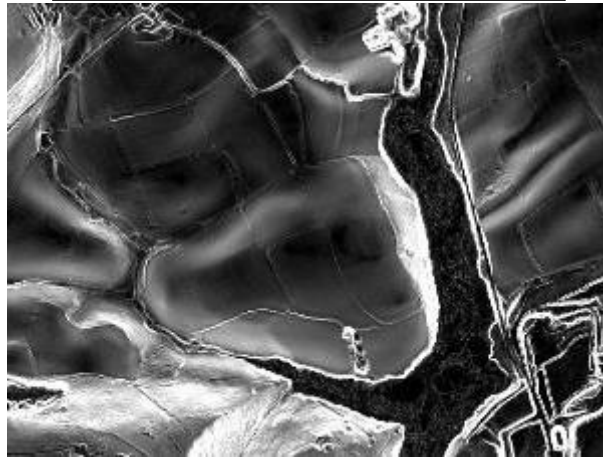
LiDAR technology uses light sensors to measure the distance between the sensor and the target object. From an aircraft this includes objects such as the ground, buildings and vegetation. For ground-based LiDAR it measures building fronts and street furniture in extreme detail. With the latest technologies it is also possible to obtain colour values of the scanned surface to create an automatically textured model. LiDAR is ideal when very high accuracy measurements are required and is very cost effective for the amount of data generated. <http://www.lidar-uk.com/>

An Example of a LiDAR Image

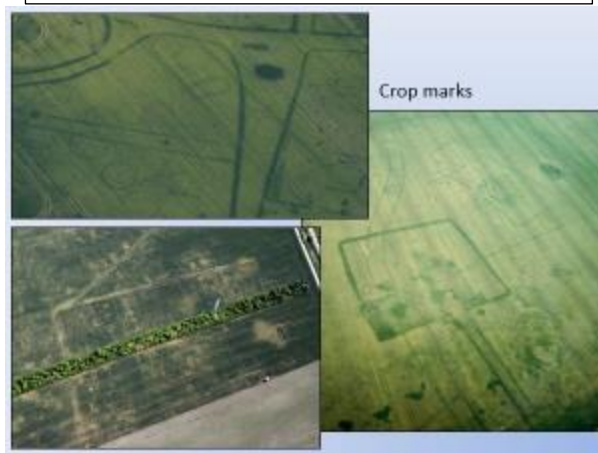
Crop Marks are a means through which sub-surface archaeological, natural and recent features may be visible from the air or a vantage point on higher ground or a temporary platform. Crop marks appear due to the principle of differential growth. One of the factors controlling the growth of vegetation is the condition of the soil. A buried stone wall, for example, will affect crop growth above it, as its presence channels water away from its area and occupies the space of the more fertile soil. Conversely, a buried ditch, with a fill containing more organic matter than the natural earth, provides much more conducive conditions and water will naturally collect there, nourishing the plants growing above.

Examples of Crop Marks in Fields

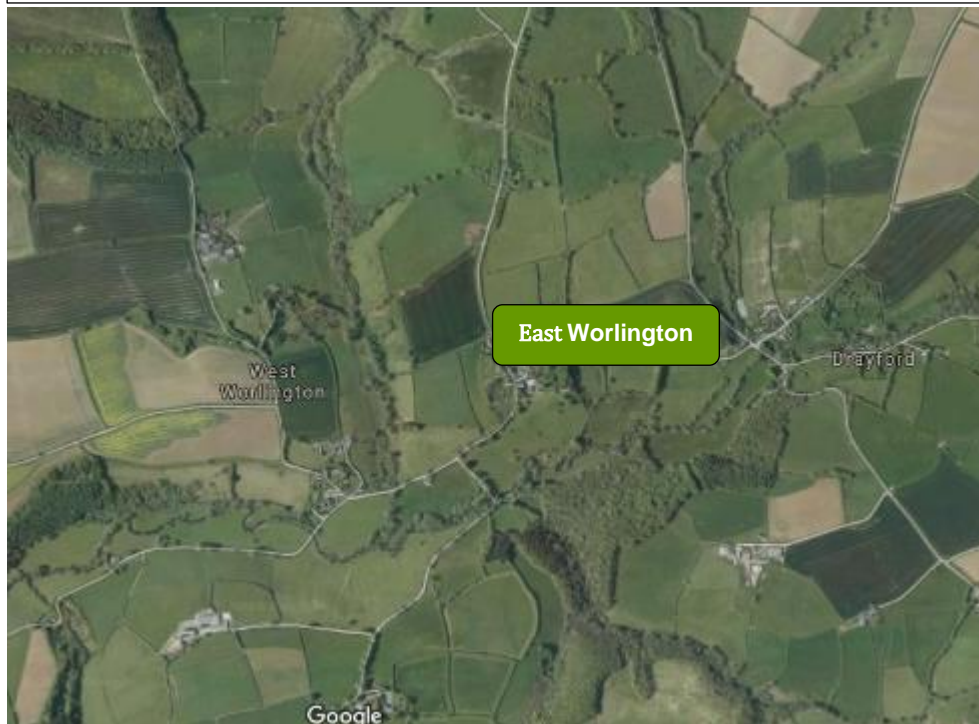
- Highly irregular field boundaries do not indicate much but may be associated with woodland or common ground.
- If field boundaries are roughly parallel and gently-curving they are like to have derived from medieval open strip fields (Devon)
- If field boundaries are generally straight and the fields large and regular, they are probably 1500 – 1800 Barton fields, semi-enclosed by agreement and often associated with Barton farms.
- If field boundaries are straight and regular and the fields rectilinear, they are probably late C18th or C19th enclosures. These are often associated with 'waste' ground (lowland moors and upland grazing)

Photograph Shows Field Boundaries Around East Worlington

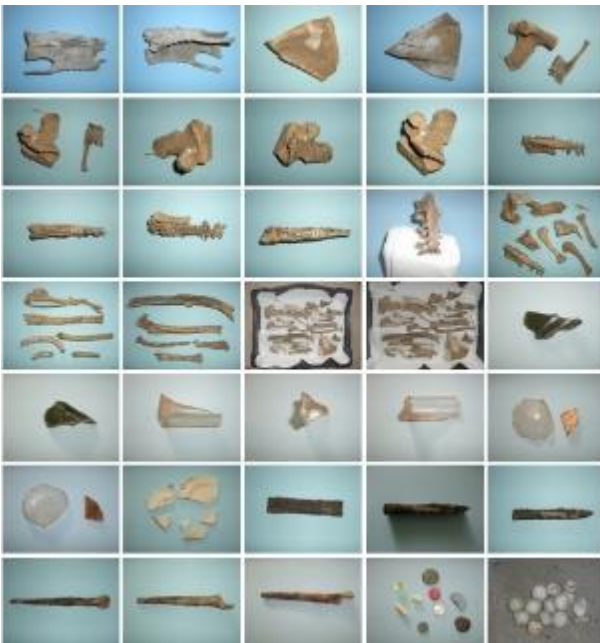
During the work on conserving the main hall between 2014 and 2016 a number of finds were discovered as shown in the photograph. These are mainly animal bones, broken glass, broken plate and metal spikes. All probably 20th Century and dating from the time the wooden suspended floor was installed in the conversion of the barn to the Parish Hall.

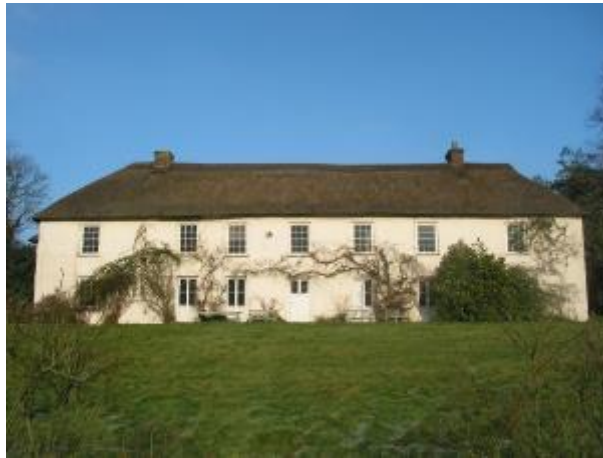
South Elevation of East Worlington House Before Investigation

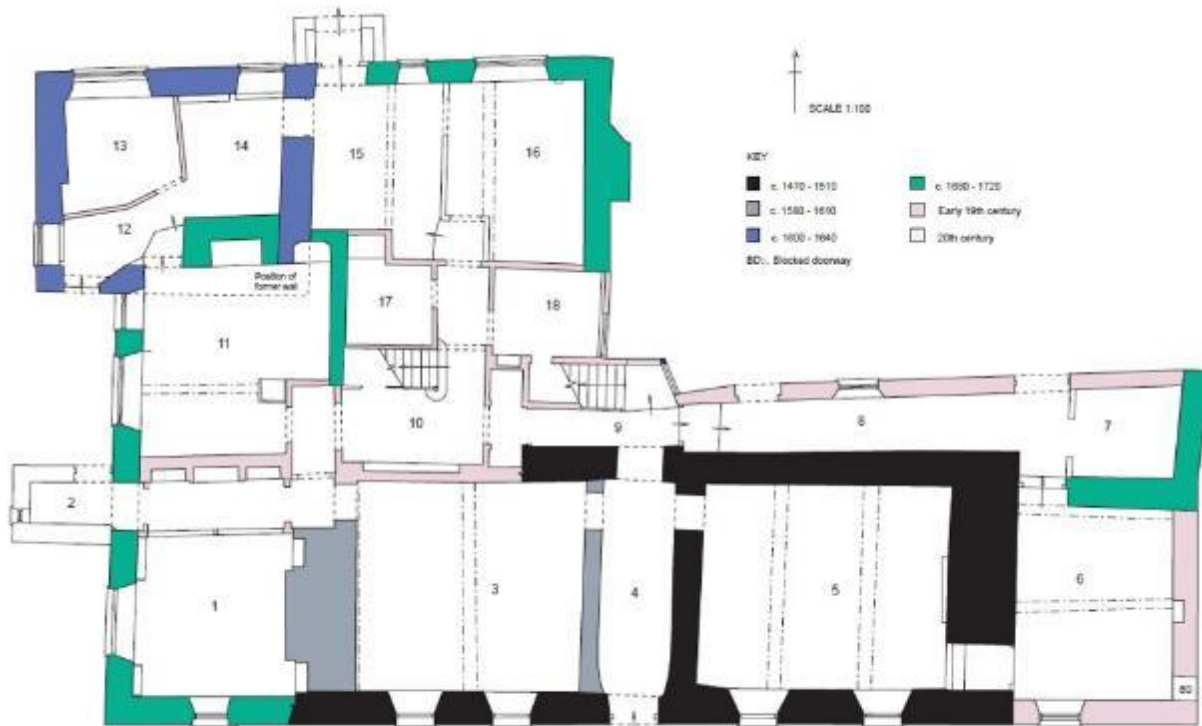
Based on initial research it was suggested the floor plan of the building and its phases of development were as shown in the plan below.

Fig ??: East Worlington House, ground floor plan showing developmental phasing

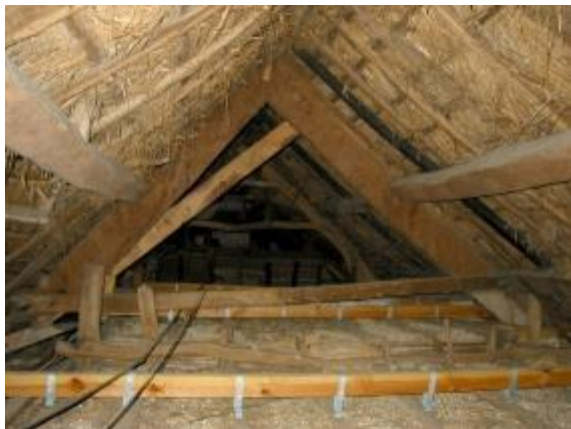
One part of the building that can provide significant evidence is the roof space. As in the roof photographs of East Worlington House different styles roof trusses unlock a story of phases of work and development of the property.

A-frame constructions joined by purlins and braced by cross members are typical roof structure and while the techniques are the same there is an evolution that can be identified based on timbers, design and jointing methods. The photographs show three distinctive styles of A-frame roof timbers within the same building and in part provide evidence of the building's evolution.

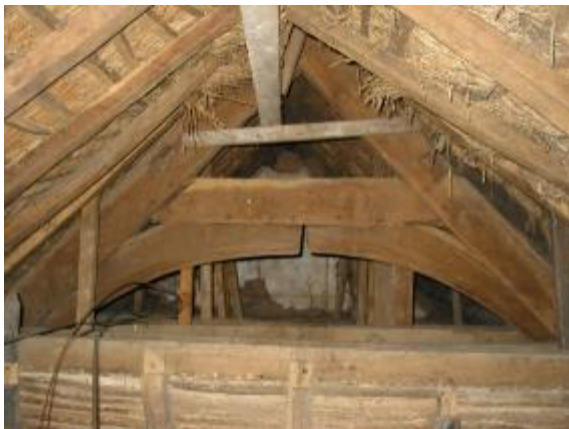
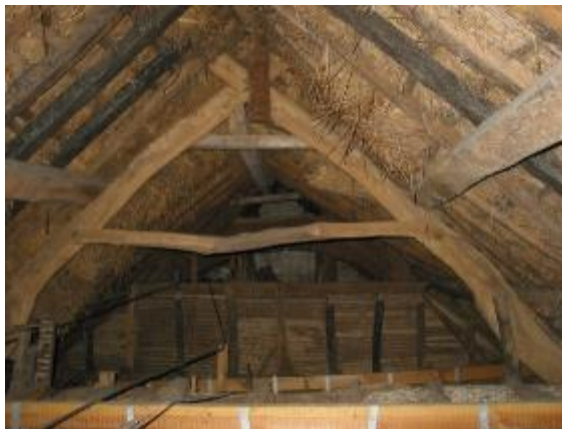
Note some of the rafters are blackened indicating at some time they were exposed to smoke probably from an open fire within the building at that time. These timbers are not in their original positions and have probably been reused during phases of development.

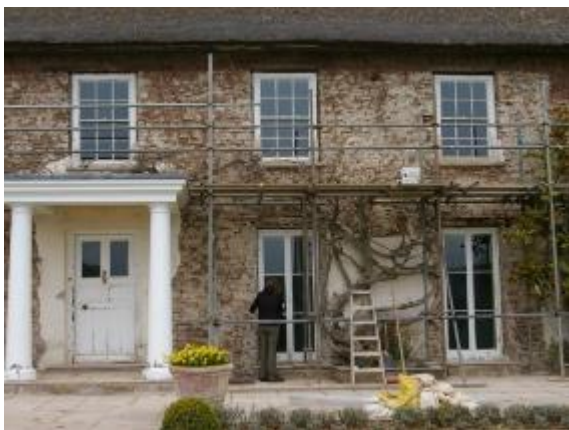
When the external render was removed from the building during conservation work there was clear evidence of different phases of development that had not shown up through other investigations. There was clear evidence in the construction of the walls and the building materials that extensions have been added which had previously been thought to be part of the original building.

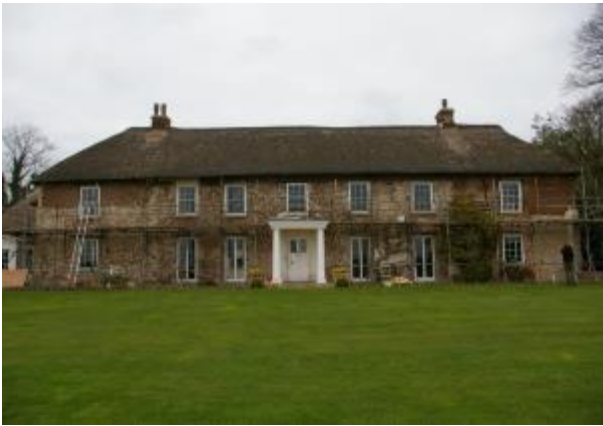
With the change from open hearth fires in the centre of the main hall to fire places with chimneys as phase of evolution can be identified at East Worlington House. Chimneys were mainly installed on external walls, partly for ease of construction and partly as a status symbol showing all that could see the building the wealth of the owner by installing a chimney fireplace. They also allowed for a second floor to be installed as the smoke would pass to the outside through the flue and not up into the open roof as previously was the case.

In the photo of East Worlington House the exposed chimney tops can be seen as an integral part of the roof indicating at one time these chimneys were on the external walls of the building at that time.

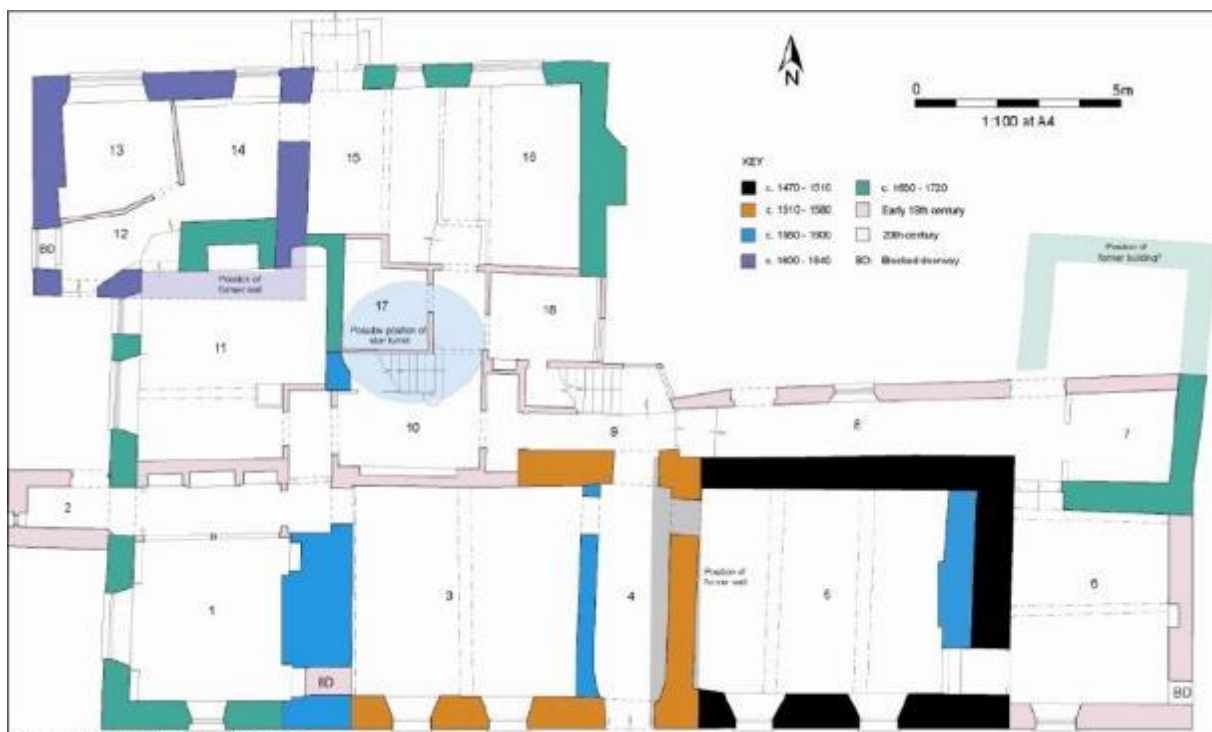
Through the archaeological survey of the building it was possible to redefine the extent of the original buildings and phases of development as shown in the plan below.

Figure 14: Phased plan of the ground floor.

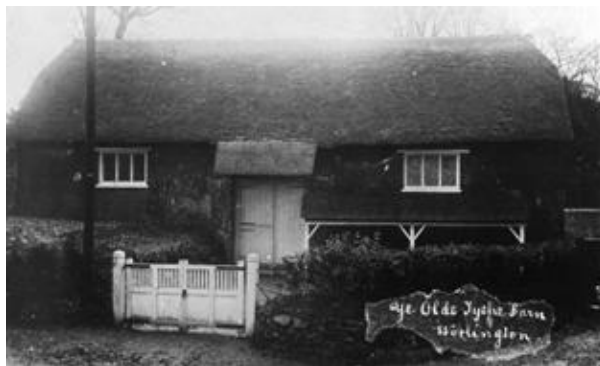
This description fits nicely with an undated photograph of the building from the early part of the 20th century.

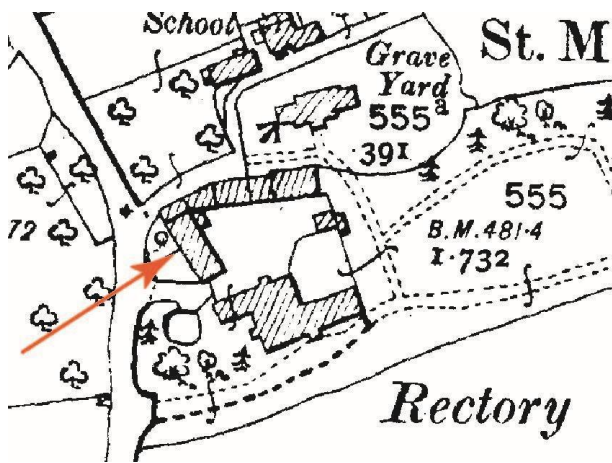
Extract from the Ordnance Survey
First Edition Map at a Scale of 1:2500
Published 1889;

The Barn is Arrowed

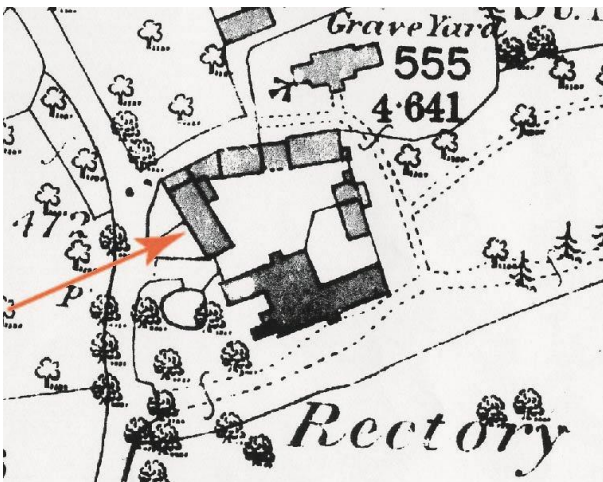
Extract from the Ordnance Survey
Second Edition Map at a Scale of
1:2500 Published 1905;

The Barn is Arrowed.

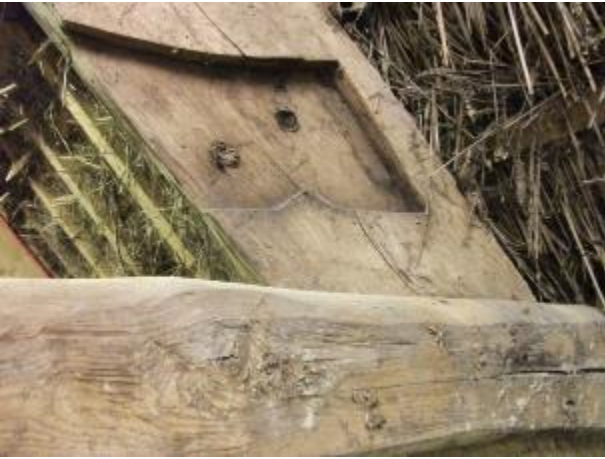
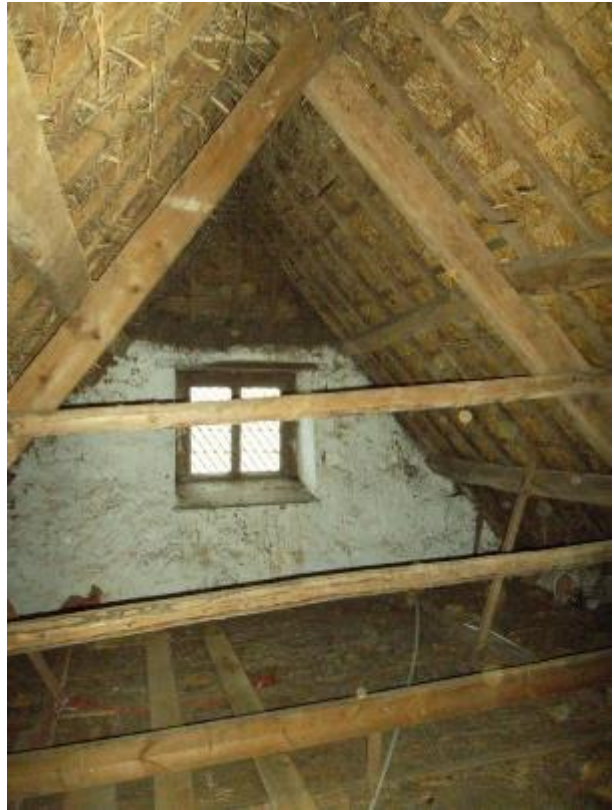
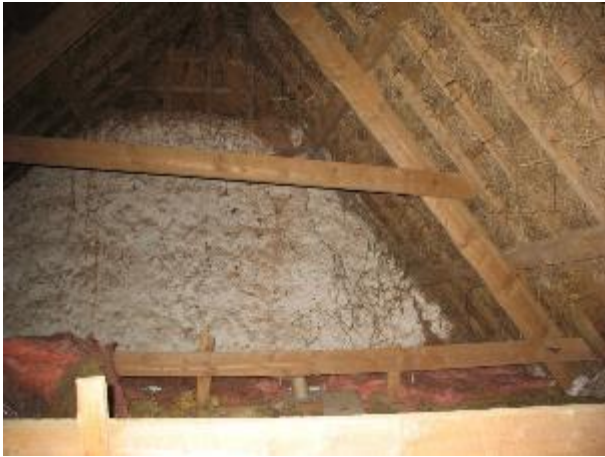
Archaeologist Report states: *'Five A-frame trusses creating six bays. Approximately, half of the major elements of the roof structure are comprised of replacement timbers, the majority of a single modern phase, during the 20th century. The majority of the newer timbers have been bolted together suggesting a later date than for the few spiked elements, which include replacement collars and ties on the remaining early roof trusses. These spiked repairs/additions are likely to be associated with the final years of the barns agricultural use and the change to community building.'*

The remaining original oak timbers are confined to the northern end of the building and are comprised of the two blades of a roughly south of centre truss, the western blade of the truss to the north of this and the eastern blade of the next most northerly truss. All original purlins on both the east and west pitch of this north end remain, trenched into the backs of the earlier truss blades, and scarfed together at this point. The truss blades are set into the wall tops to east and west. All common rafters, battens and the ridge pole are modern and have been replaced during the 20th century, appearing contemporary with most of the replaced roof trusses to the south. The structure is now covered with a seemingly thin layer of thatch, with the feet of the spars protruding through for up to 0.15m. All collars and tie beams on the remaining early truss blades are replacements, bolted or spiked to the faces of the blades. The single remaining complete A-Frame truss is lapped and pegged at the apex and the former collar was affixed via face pegged notched lap-joints.

The two modern trusses to the south appear to have replaced a former single truss, the space between them is .5m -1.0m less than between the older trusses to the north.

The wall tops and the three quarter height gables are whitewashed as are the feet of the rafters suggesting they were replaced prior to the wall being painted. The majority of the roof timbers show no clear sign of ever having been painted and are not blackened. The slight modern ceiling joists have been fixed by simply gouging out a slot downward from the top of the walls and then inserting the timber.'

The photographs below show the features of the roof prior to 2014.

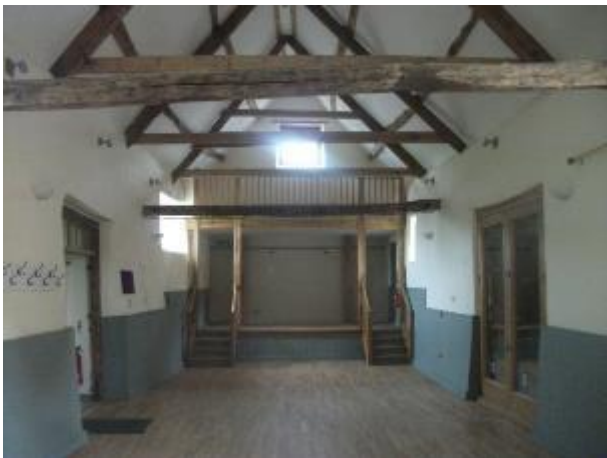
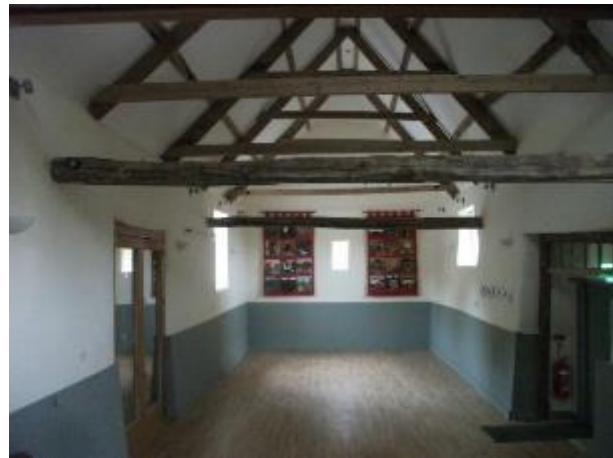
The conservation and improvement work completed in 2016 removed the old suspended ceiling and repaired and conserved the roof timbers exposing them to view from the hall. The photographs below show the roof timbers following the completion of the work. This gives a perspective of the layout of the hall roof when it was a barn.

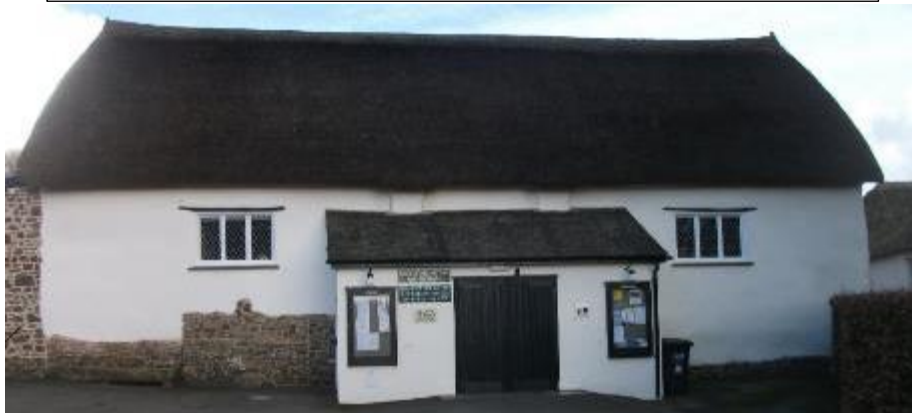
East Worlington Parish Hall is typically thatched in the Devon vernacular as shown in the photographs below. The Hall was re-thatched in 2016.

Front View of Hall Showing Thatch with Overhang

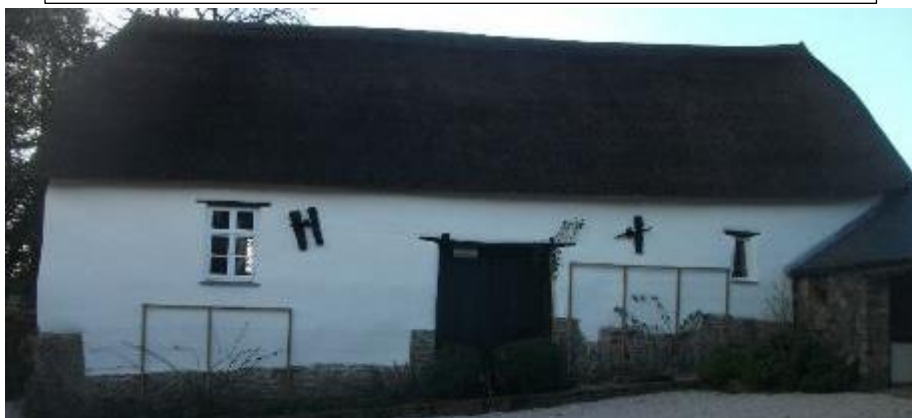
Rear View of Hall Showing Thatch with Overhang

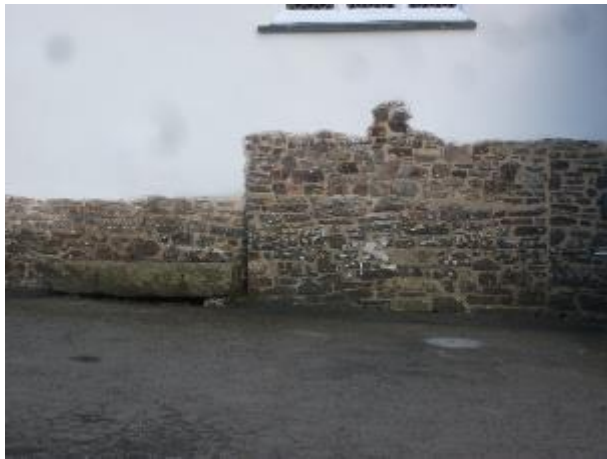
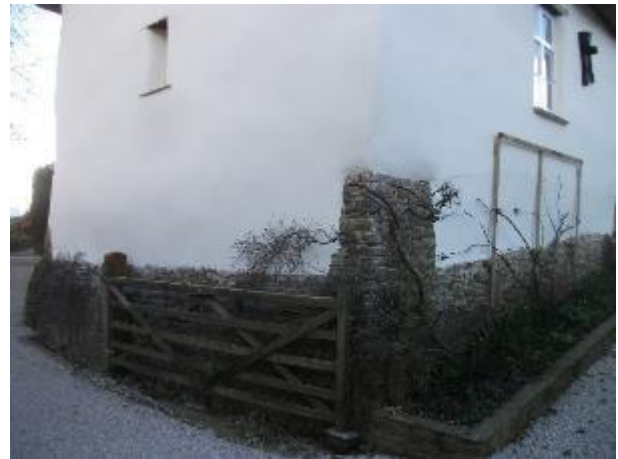
Cob walls are built off a stone plinth, which can vary in height from approximately 300mm to 450mm and between 400mm and 600mm wide

East Worlington Parish Hall Stone Plinth with Lime Mortar Supporting the Cob Walls

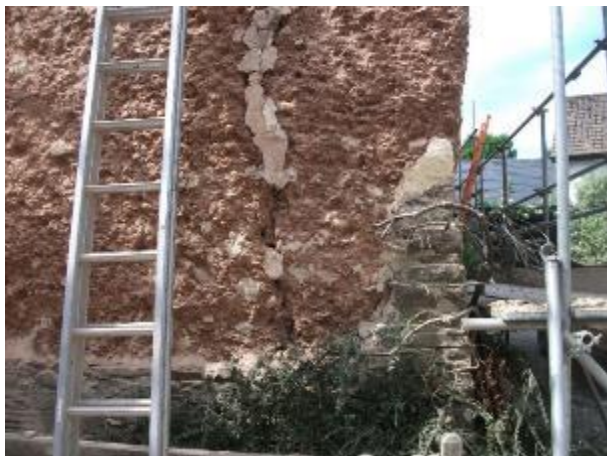
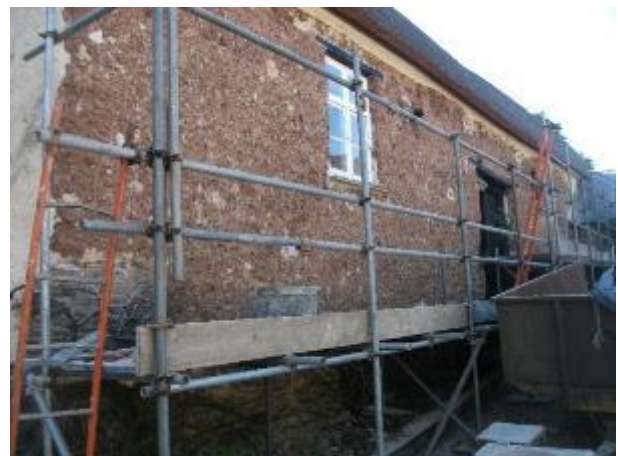
Cob is a mixture of subsoil, straw and water. Traditionally, the cob would have been mixed by fork and foot or trampled overnight by bullocks. The cob mixture was traditionally placed on the plinth with a pitchfork and tread it down by foot to compact it. A layer of cob is called a lift. The first lift of cob is left to dry for a few days and then pared back into shape with a spade or mattock. The material overlapped the stone plinth by around 100mm, with surplus being removed before commencing the next layer. Further lifts are then built until the wall is high enough.

Exposed Cob Walls of the Parish Hall Showing the Condition and Materials Used

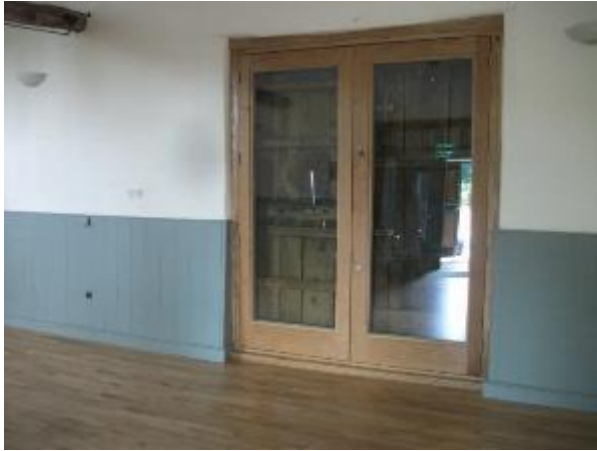
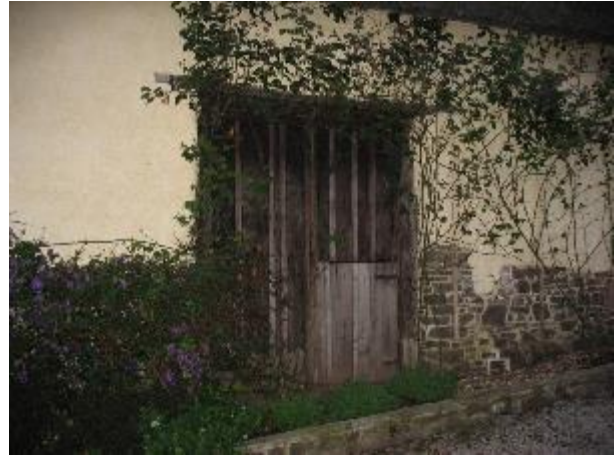
The old barn door on the east elevation remains and is shown on the photographs below. The internal side of the door is now covered and protected by a glazed door which offers full view of the old door.

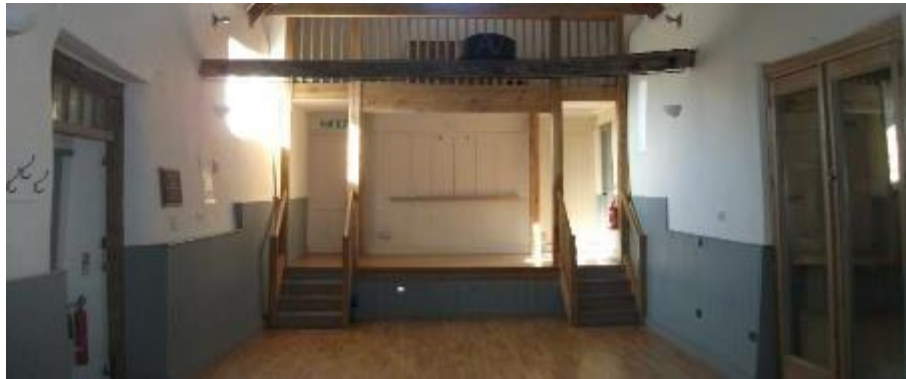
The opening for the barn door on the west elevation remains can be seen but the doors removed and externally covered by a C20th foyer extension. Both doors are visible in the photograph below.

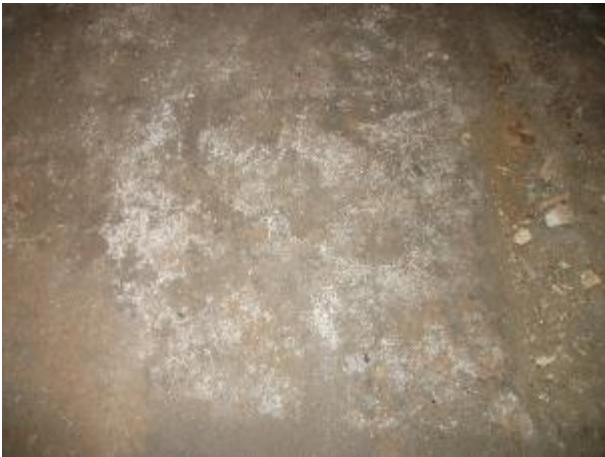
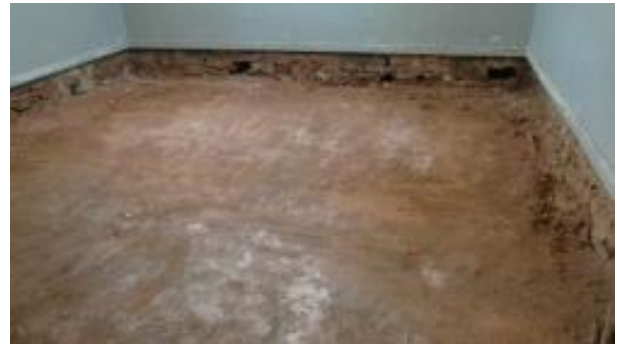
The floor in the south end of the barn from wall to doors is natural local clay soil that has been levelled and compacted either through general usage or (more likely) beaten to form a solid surface such as those in traditional threshing floors.

The photographs show the hard-compacted surface and the white colour which suggests chalk or lime was used on the floor of our barn.

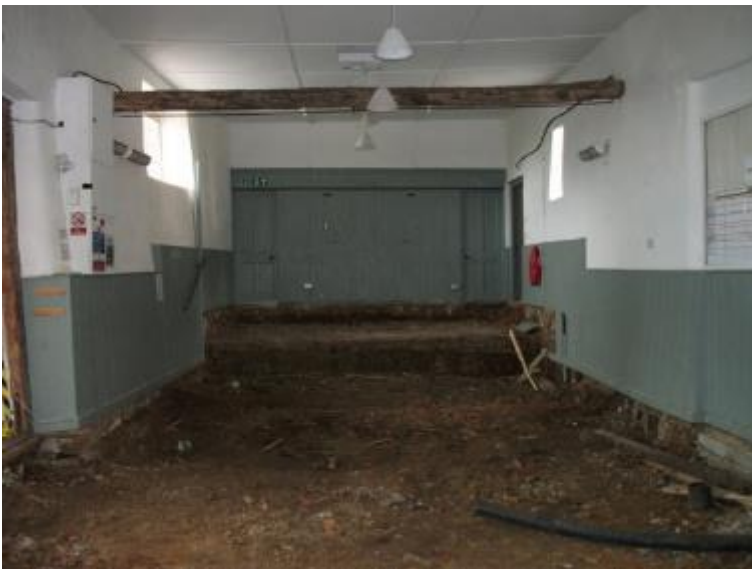
There were signs of two parallel depressions running between the doors in the east and west walls which were almost certainly the impressions of wheels on carts that would have been driven through the doors when the hall was used as a tithe barn or storage barn.

The walls to the north of the doors showed clear signs that the original floor sloped up from the level south end by about 0.75m. It seems likely that when the building was converted to its current use as a parish hall the floor was dug out to about 1.25m from the north wall to accommodate the wooden floor in the main hall area, and the hall stage was built over the remaining higher area.

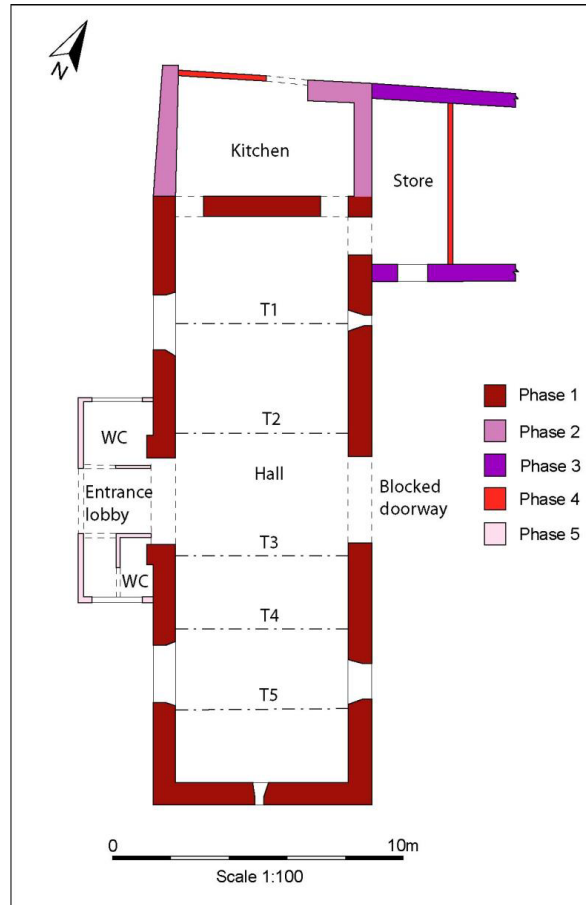
The diagram below shows the stages of development of the barn to its current use as a Parish Hall.

Phase 1 is the original barn showing the large doors opposite each other in the elevations of the wall to the east and the wall to the west. (Glebe Terriers, which are accounts of church land and holdings were researched dating from 1605(?), 1613, 1679 and 1727. The two earlier documents refer only to the land, but the documents of 1679 and 1727 include descriptions of the house and curtilage, suggesting a building date between 1613 and 1679).

Phase 2 is now the kitchen of the Parish Hall. Original it was a stone built lean-to against the north wall of the old barn. These types of lean-tos were traditionally built to house livestock and/or provide a space for farm tools and equipment.

Phase 3 shows the construction of an extension which joined the lean-to to the large barn and stables of the rectory (now East Worlington House). This provided a covered storage area for the rectory. There was no access to the lean-to.

Firstly, a block wall with a door for access was constructed across the opening of the lean-to to form an enclosed area which initially housed a kitchen and cloakroom. (The cloakroom was removed with the development of phase 5 and the whole area became a kitchen.)

The second aspect of phase 4 was the introduction of a storeroom off the main hall. This was achieved by the owner of East Worlington House donating part of the store associated with the rectory built in Phase 3 construction a separating wall and creating a doorway between the new storeroom area and the main hall.

Phase 5 was the construction of a lean-to foyer and toilet to the west elevation and covering and extending beyond the span of the original barn door.
