# East Worlington Parish Hall News|etter

## **Render and Window Project Edition 05 – 10 August 2018**

### **Rendering, Rendering and More Rendering**

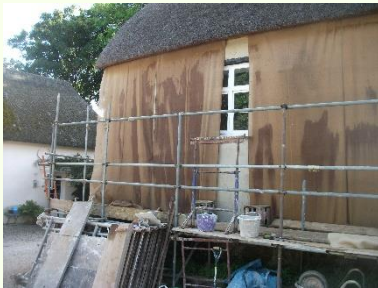
**East Elevation**

This week has seen good progress with the rendering. Finishing coats have been applied to the east elevation, the south elevation and the southern end of the west elevation. The render is applied on one day and allow to dry slowly for 24 hours with final smoothing on the following day. When the render is applied, the walls are protected by canvas sheets. This is mainly to prevent the warm sun drying the render too quickly which can cause cracking through too rapid shrinkage. The protection is also against any rain that may fall and affect the drying process.

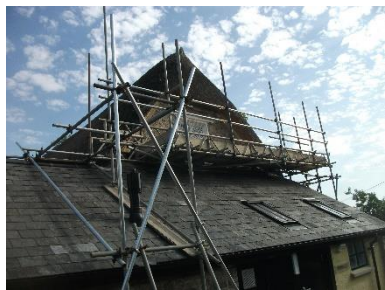
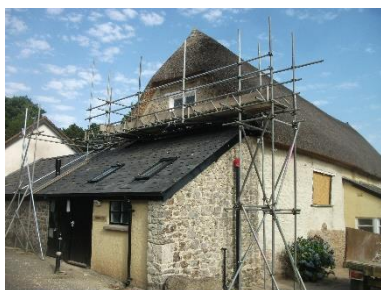
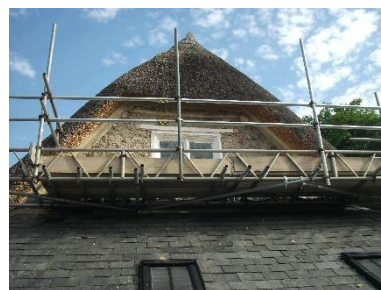
### North Elevation

The North Elevation of the main barn is located above the kitchen. To gain access it has been necessary to erect scaffolding. Once in place work started to remove the old render and apply the new render in the three coat process – harl coat, scratch coat and finishing coat.

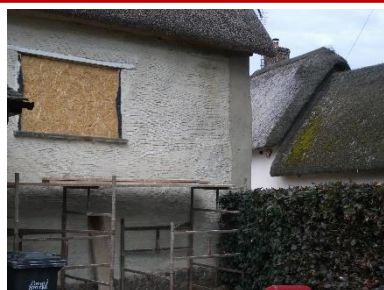
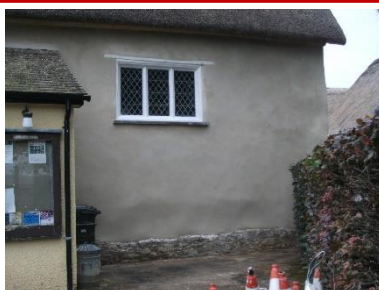
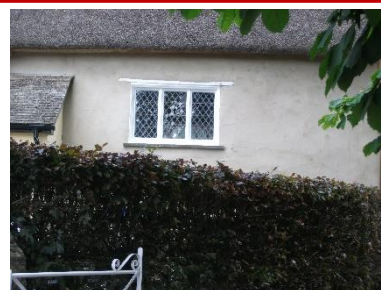
### Window and Render West Elevation

With the old window removed and the temporary board installed it was only possible to initially add a scratch coat to the west elevation. This is to ensure that when the repaired window was installed the final coat was applied there was a good seal between the wall and window..
