# East Worlington Parish Hall News|etter

**Render and Window Project Edition 06 – 17 August 2018**

## Repaired Window Installed

## Render and Window Project

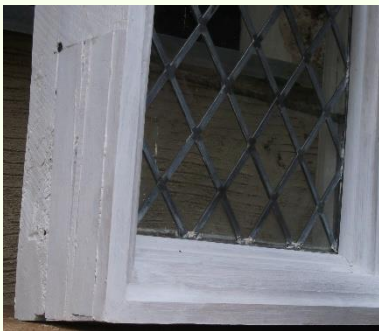
The bottom rail showing the scarf joint on the jamb

The second repaired window was installed during this week. Haydons of South Molton were the firm that undertook the repair. The rotten timber, which was mainly the bottom rail rising up the jambs and mullions, was removed. New timber was profiled to match exactly the timber that was removed. This new timber was joined to the existing frame by using scarf joints.

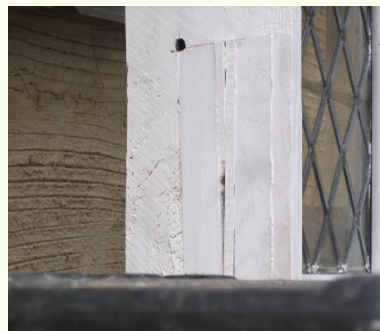
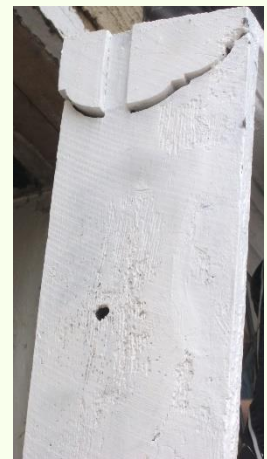
Header joint  
with jamb

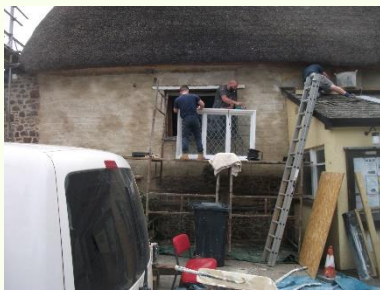
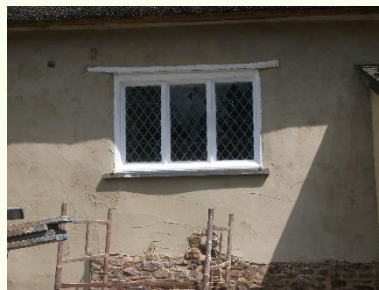
Fitting the repaired window and the window in situ

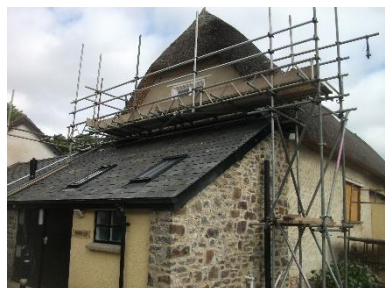
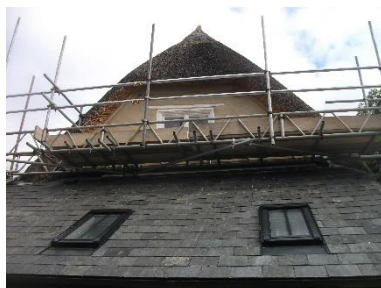
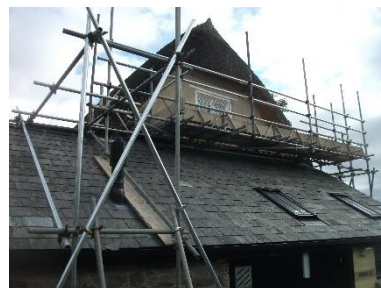
### North Elevation – Finish Coat Applied

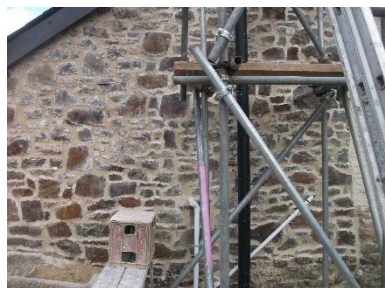
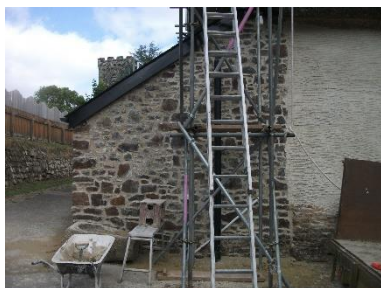
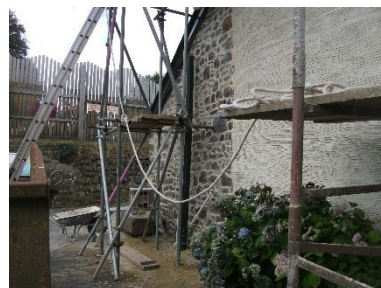
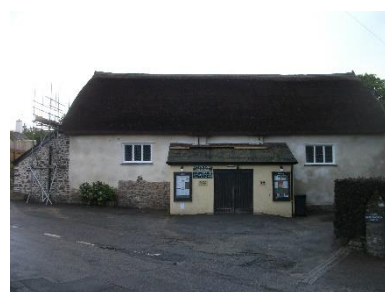
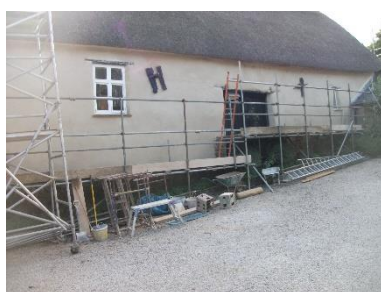
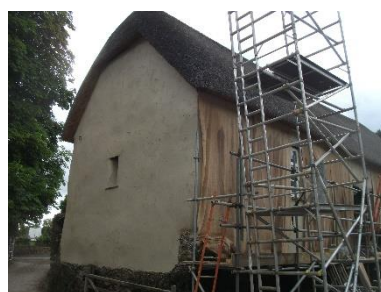
### West Elevation – Stone Wall Pointing Finished
