East Worlington Parish Hall

Heritage Project 2017 – 2019 Conservation and Celebration: A Century Serving Our Community as a Parish Hall

Conservation and Refurbishment of the Kitchen

Needs Identification: Building Condition

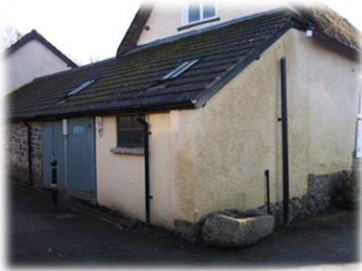
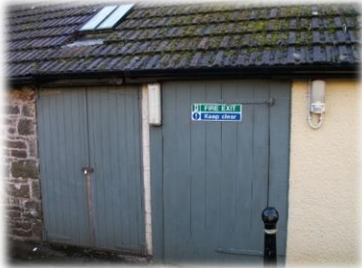
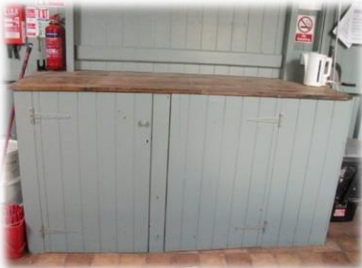
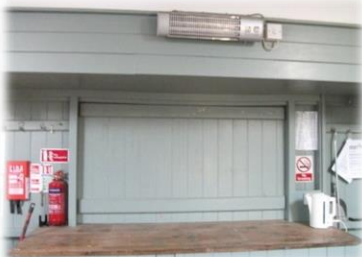
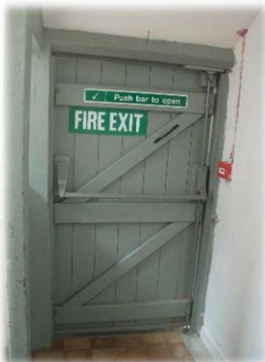
- Heating – currently ineffective and inappropriate single high level single bar wall heater.
 - Fails to provide sufficient heat to work in kitchen in cold weather.

- Creates condensation.
 - Danger of frozen pipes in cold weather.
- External roof – The original roof of the lean-to, which is now the kitchen, was originally made of slate. This was replaced with concrete tiles when the roof fell into disrepair. This compromises the heritage value of the building and adds unnecessary weight to aging timber supports.

- The external wall to the north has been built of single skin blocks and has inadequate insulation value.
- The walls, because of their construction, are currently difficult to keep clean adding to an environmental health concern.

- The wall to the west is of cob and stone construction and is affected by condensation.
- The wall to the east is of uneven stone construction and is the partition wall between the kitchen and the storeroom and in need of skimming.

- The kitchen external door is ill-fitting and allows drafts and heat loss.
- The kitchen window in the north wall is single glazed and does not provide sufficient insulation.

- Two roof lights are single glazed and do not provide sufficient insulation and increase condensation problems.
- The electrical infrastructure is in need of modernisation.

- Old wooden cupboards and wooden working surfaces are inadequate and provide an environmental health hazards.
- Dampness is extensive and facilitates the growth of mould which is an environmental health hazard.

- The floor has no insulation, is of a loose stone sub-level with a thin layer of surface concrete and is uneven.
- The plumbing and water heating arrangements need improvement.

- Install heating connected to the heating arrangements for the rest of the hall.
- Install insulation and damp proof membrane under new solid floor.
- Install two new double-glazed Velux roof lights.
- Replace window in north wall with a double-glazed unit.
- Add insulation to ceiling.
- Add an insulation solution to single skin North external wall and skim plaster.
- Plaster east and west integral walls to provide smooth surface for painting and cleaning.
- Add wall tiles above all work and cooking surfaces.
- Install cooking extractor fan.
- Renew to current standards the electrical circuits and fittings.
- Refit external door.
- Replace the concrete ceiling tiles with slate tiles and add breathable membrane and insulation.
- Replace and install all new kitchen units and worktops.
- Improve the plumbing and water heating arrangements.
