# East Worlington Parish Hall Newsletter

**Project Edition 03 - Week Ending 12 January 2018**

## **Parish Hall Kitchen Refurbishment Project**

### **Week Two**

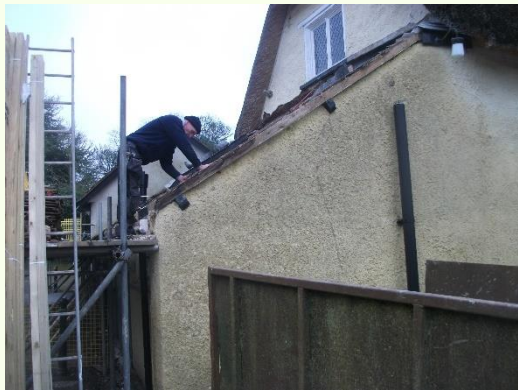
The main focus this week has been to prepare the roof in readiness for the new slates.

Firstly the old concrete tiles, old lathes, and old felt, had to be removed.

The rafters were generally in good condition and if any were showing signs of rot, especially where they rested on the outside wall, they were repaired.

All the roof timbers were treated for added protection against future rot and any infestation.

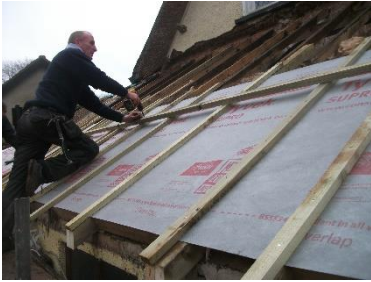
This photograph shows that the old tiles, lathes and felt are stripped from the roof. Mark is working on the roof to fix the new membrane and new lathes.

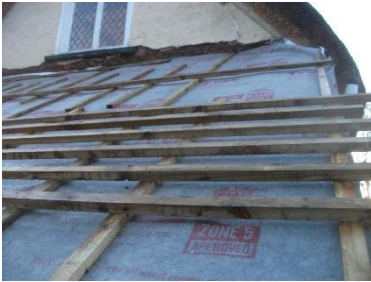
This photograph shows the new membrane has been fixed and the tiling lathes being spaced and fixed.

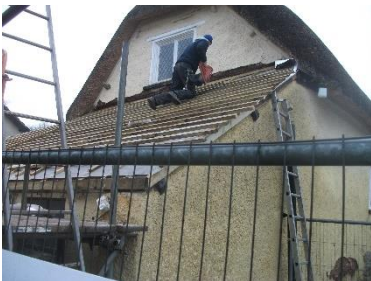
The final lathes are being fixed. Lead flashing will be added to make a water tight seal between the cob wall of the Hall and the new tiled roof.

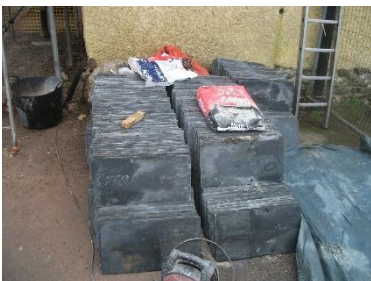
Natural slate tiles are being used. This week they arrived on site and are now ready to fix. Firstly the new Velux roof windows needed to be installed.
